Section 19 Flood Investigation

23 September 2024 Flood Event

HILLINGDON
LONDON

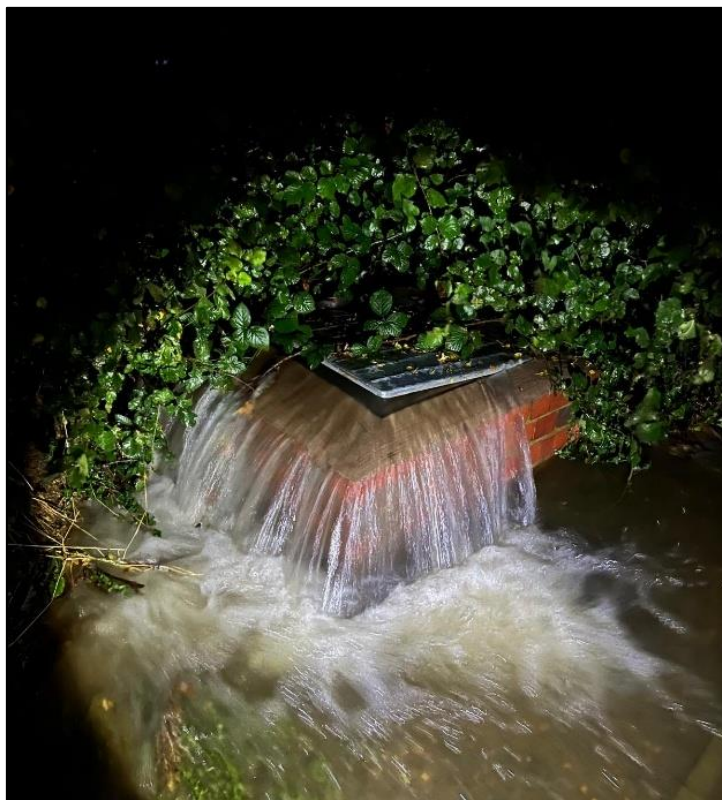
- 5.2.3 The detention basins implemented within Bessingby Park was designed to alleviate against the 1 in 5 year rainfall event, so these were less effective at managing surface water runoff during this more intensive rainfall event and the exceedance flows ran onto Whitby Road via the footpath between 123 Whitby Road and 180 Pavilion Way. As detailed in 3.3, the water levels in the Yeading Brook West rose during the rainfall event which reduced the ability of the surface water sewers to discharge, limiting how much surface water could drain away from Whitby Road. This was exacerbated as all the surface water sewer pipes in the catchment converge at Whitby Road. The volumes of water reaching this confluence was greater than the capacity of the network here, causing the sewer to surcharge as shown in Figure 5-4.

Figure 5-4: Photograph of the surface water sewer in Bessingby Park surcharging on the 23 September 2024.
Image credit: Whitby Road resident.

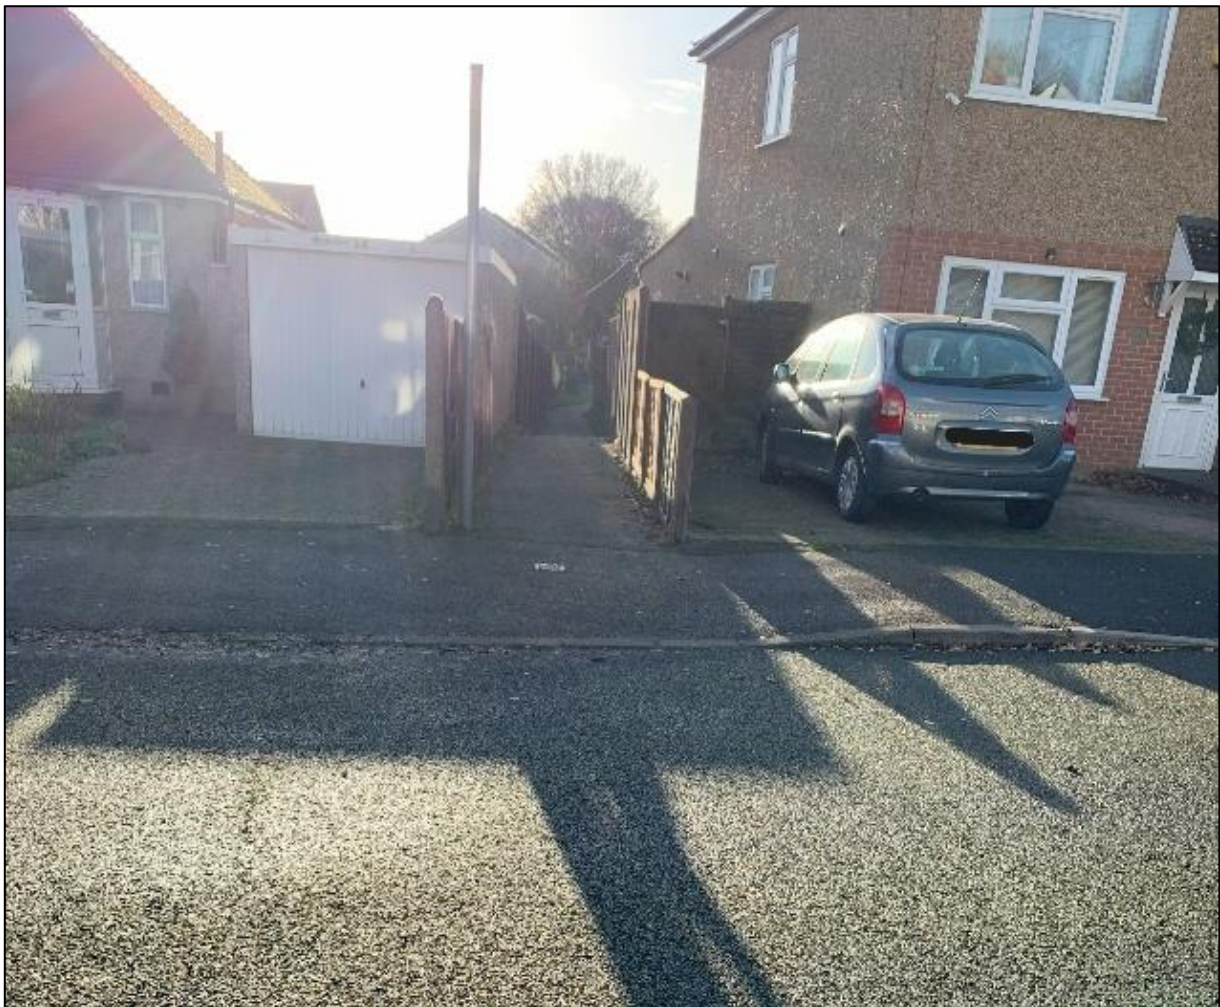
- 5.2.4 In the north-west corner of the catchment, it was noted that surface water follows the topography of the land off the railway footbridge onto Linden Avenue and then straight down the footpath towards Beech Avenue, which is pictured in Figure 5-5. There is no gully at the junction between Linden Avenue and the footpath heading down towards Beech Avenue. The TWUL sewer network mapping shows that the gullies on either side of this point are the head of separate sewer runs that flow in opposite directions.

Figure 5-5: Photograph of the junction between Linden Avenue and the footpath to Beech Avenue. Image credit: Metis Consultants Ltd.

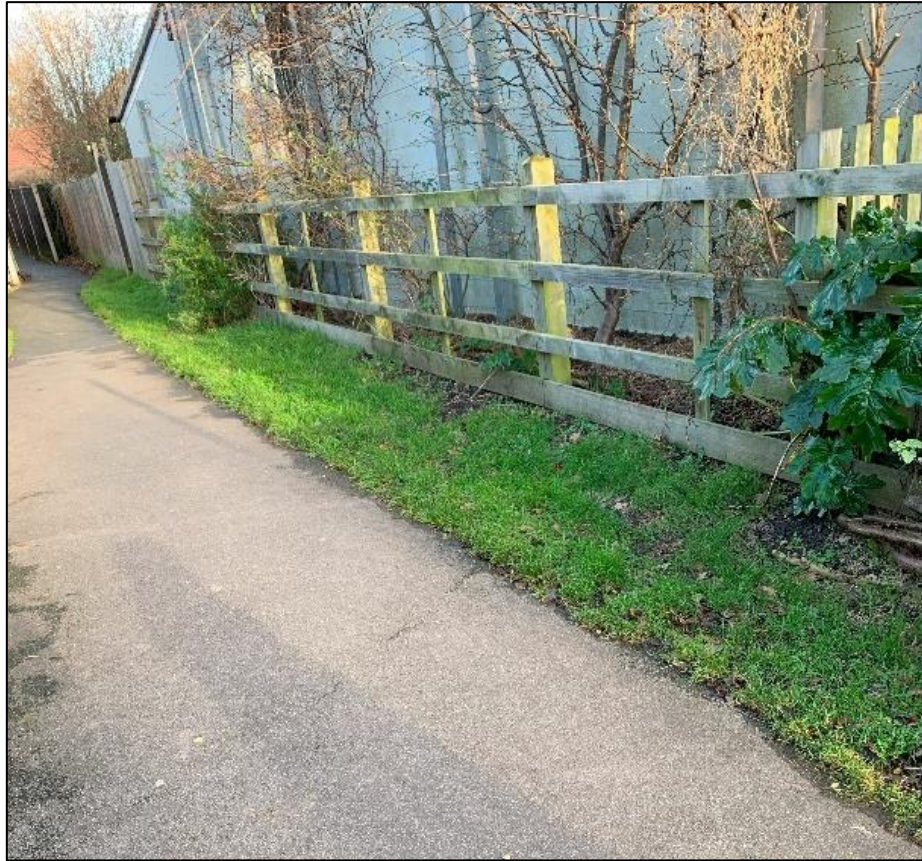
- 5.2.5 There are gullies on both sides of the road at Beech Avenue, however, the gullies closest to the end of the road are not in a position to capture any of the surface water running down the footpath before it reaches Beech Avenue properties. The only green space between Linden Avenue and Beech Avenue is a relatively narrow strip along the western edge of 58 Beech Avenue, pictured in Figure 5-6. Therefore, the likely cause of internal flooding along Beech Avenue was due to limited interception from gullies or green spaces resulting in large volumes of surface water flowing from Linden Avenue to Beech Avenue and entering the property through low-lying doors.

Figure 5-6: Photograph of the green space between Linden Avenue and Beech Avenue. Image credit: Metis Consultants Ltd.

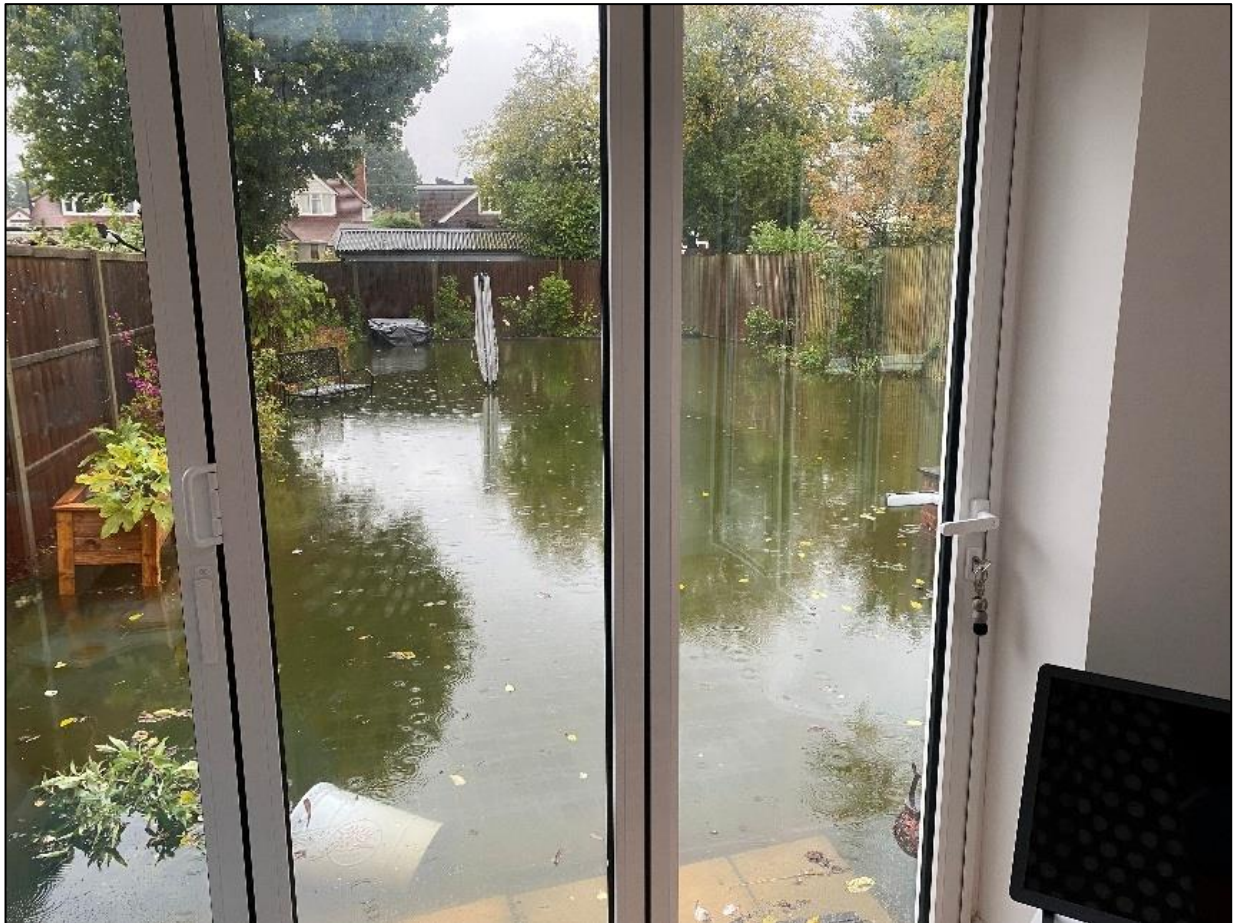
- 7.2.6 Further investigative work is outlined in the recommendations. Ultimately, the rainfall event led to large volumes of surface water flowing through the back gardens of Hoylake Crescent properties towards the River Pinn, as shown in *Figure 7-5*. This water was reportedly able to enter two Hoylake Crescent properties through low-lying airbricks and back doors. Property level resilience measures should be considered for these properties.

Figure 7-5: Photograph of surface water flooding to the back garden of a Hoylake Crescent property on the 23 September 2024. Image credit: Hoylake Crescent resident.

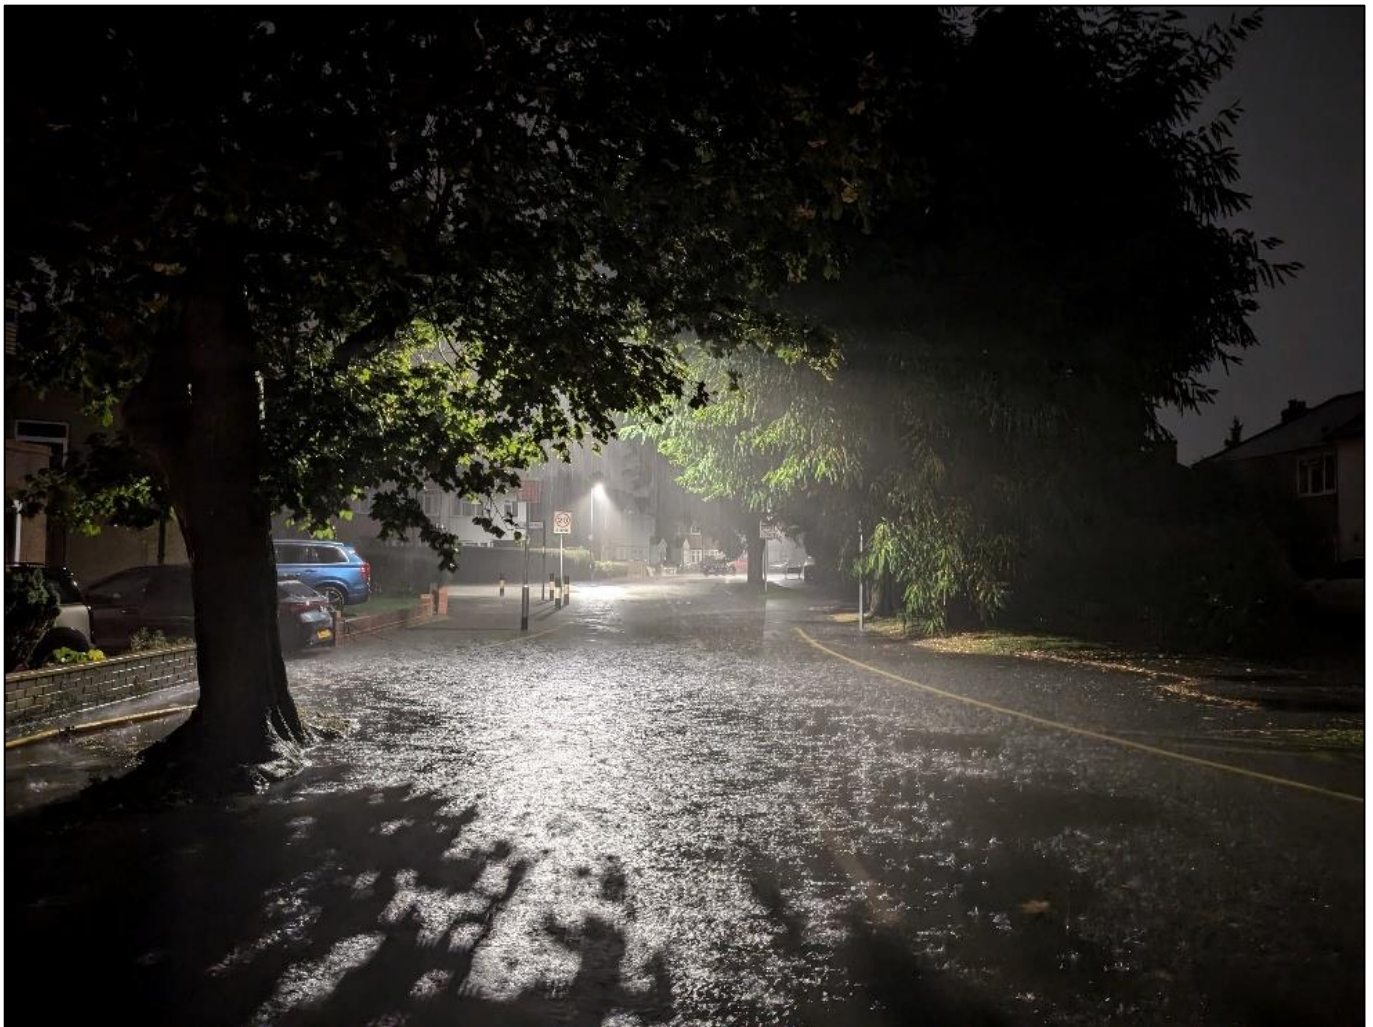
- 8.2.2 There is no data that shows how the levels in the Ickenham Stream responded to the rainfall event. However, the Ickenham Stream is a tributary of the Yeading Brook West which does have water level data available, described in 3.3. It is likely that the water levels in the Ickenham Stream reacted similarly to those in the Yeading Brook West, rising overnight between the 22 and 23 September, but not breaching its banks. The rising levels in the Ickenham Stream likely reduced the sewer network's ability to discharge, limiting its capacity to drain runoff from the surface. Therefore, surface water flowing from the north-west of the catchment was able to accumulate along Glebe Avenue as shown in *Figure 8-5*. Surface water flowed into the driveways of Glebe Avenue properties across dropped kerbs and caused internal flooding from the front.

Figure 8-5: Photograph of the surface water flooding along Glebe Avenue on the 23 September 2024. Image source: Glebe Avenue resident.

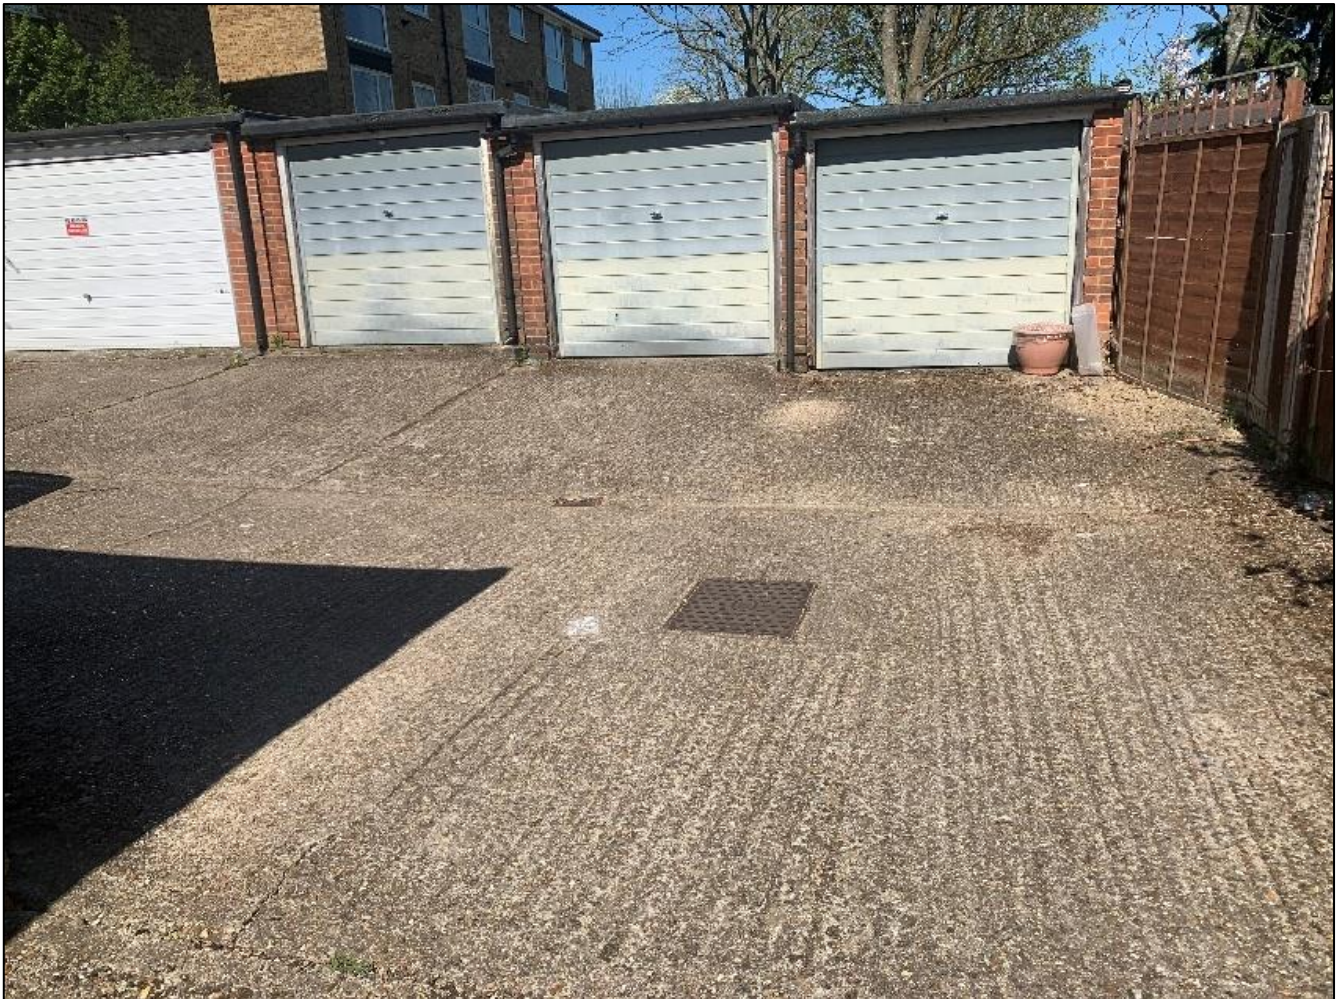
- 8.2.4 The cause of the internal flooding incident along Aylsham Drive was likely due to a more localised issue in the drainage system. Surface water runoff is expected to flow from Aylsham Drive down Melville Close and onwards towards Ickenham Marsh and the Ickenham Stream. A private drain at the back of the flood-affected property, shown in Figure 8-6, is situated at a low point along this flow path. It is probable that this drain reached capacity, leading to surface water accumulating at the back of the Aylsham Drive property and ultimately entering the property through the back door.

Figure 8-6: Photograph of the private drain located at the back of the flood-affected property on Aylsham Drive.
Image credit: Metis Consultants Ltd.

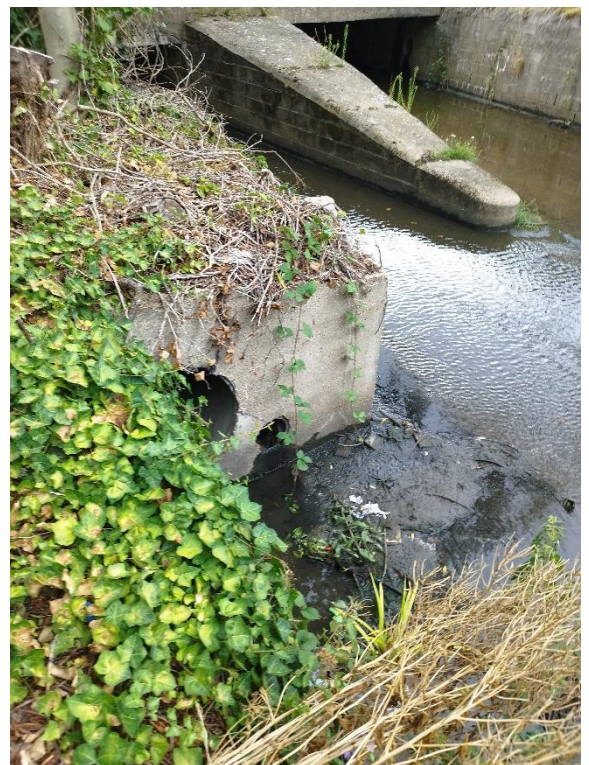
9.2.3 It is necessary to note that the outfalls are particularly low within the Yeading Brook West (see image right). Whilst the river, as reported by residents, was far from 'full', it is the height of the outfalls that are material to the cause of flooding. The outfalls become less able to function as the water level rises; eventually the force of flow from the outfall into the river is not sufficient and the network becomes locked and backs up. This is evidenced by the flood risk mapping that shows Clyfford Road not at risk from river flooding even in the extreme 1:1000-year event, whilst being at risk from surface water flooding in much lower events (e.g. 1:30 year).

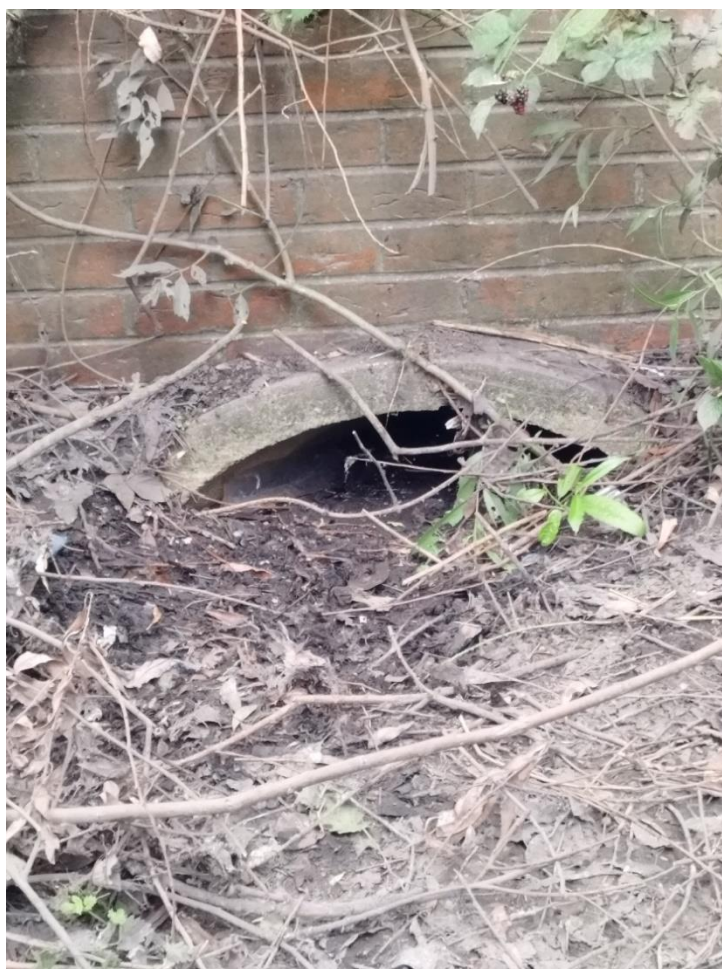
9.2.6 Firstly, it confirmed the observations regarding the relatively low level of some drainage outfalls. The image to the right shows the outfall that takes water north of the catchment and is consistent with other outfalls on the western bank of the Yeading Brook. These outfalls are sunk low in the embankment which means moderate water rise in the river would submerge the outfall rendering them ineffective.

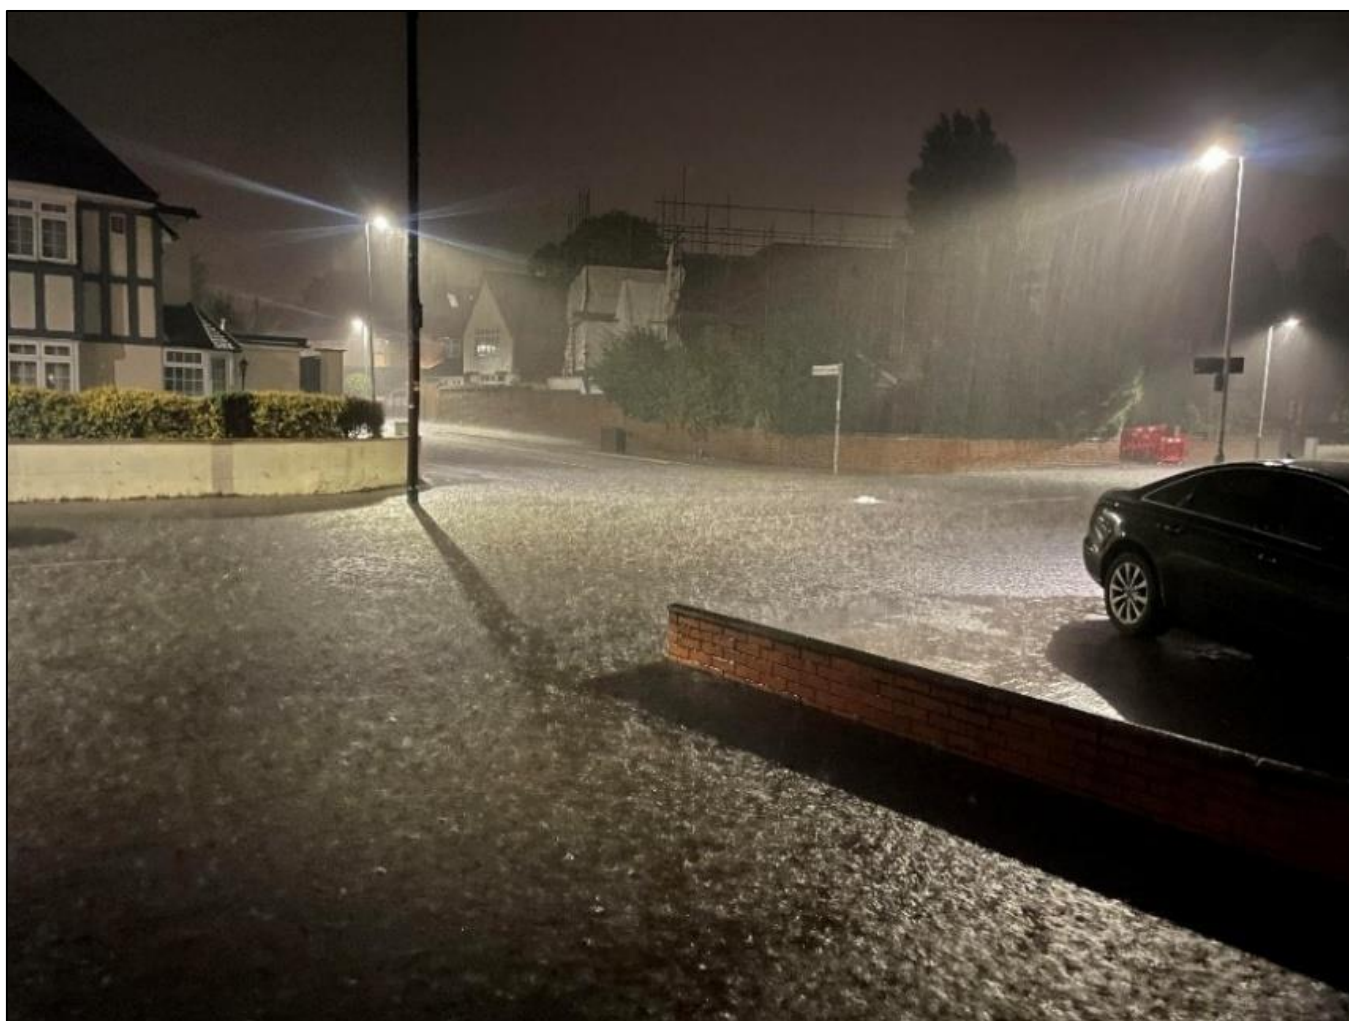
- 10.2.1 LiDAR data shows that the Yeading Brook East is a low point in Catchment 17, which means rain that falls within the catchment is likely to travel towards this watercourse. Considering this, surface water runoff from Mount Pleasant and Queens Walk likely flowed southwards towards The Fairway and accumulated at the front of the north-facing properties, as shown in *Figure 10-4*.
- 10.2.2 High water levels in the Yeading Brook East, as evidenced by 3.3, would have reduced the ability of the surface water sewer network to discharge and limited its capacity, increasing the volumes of water accumulating on the surface. The accumulation of surface water was great enough to cause water to enter some of these properties through low-lying airbricks.

Figure 10-4: Photograph of surface water accumulating outside The Fairway properties opposite the junction with Mount Pleasant on the 23 September 2024. Image credit: The Fairway resident.

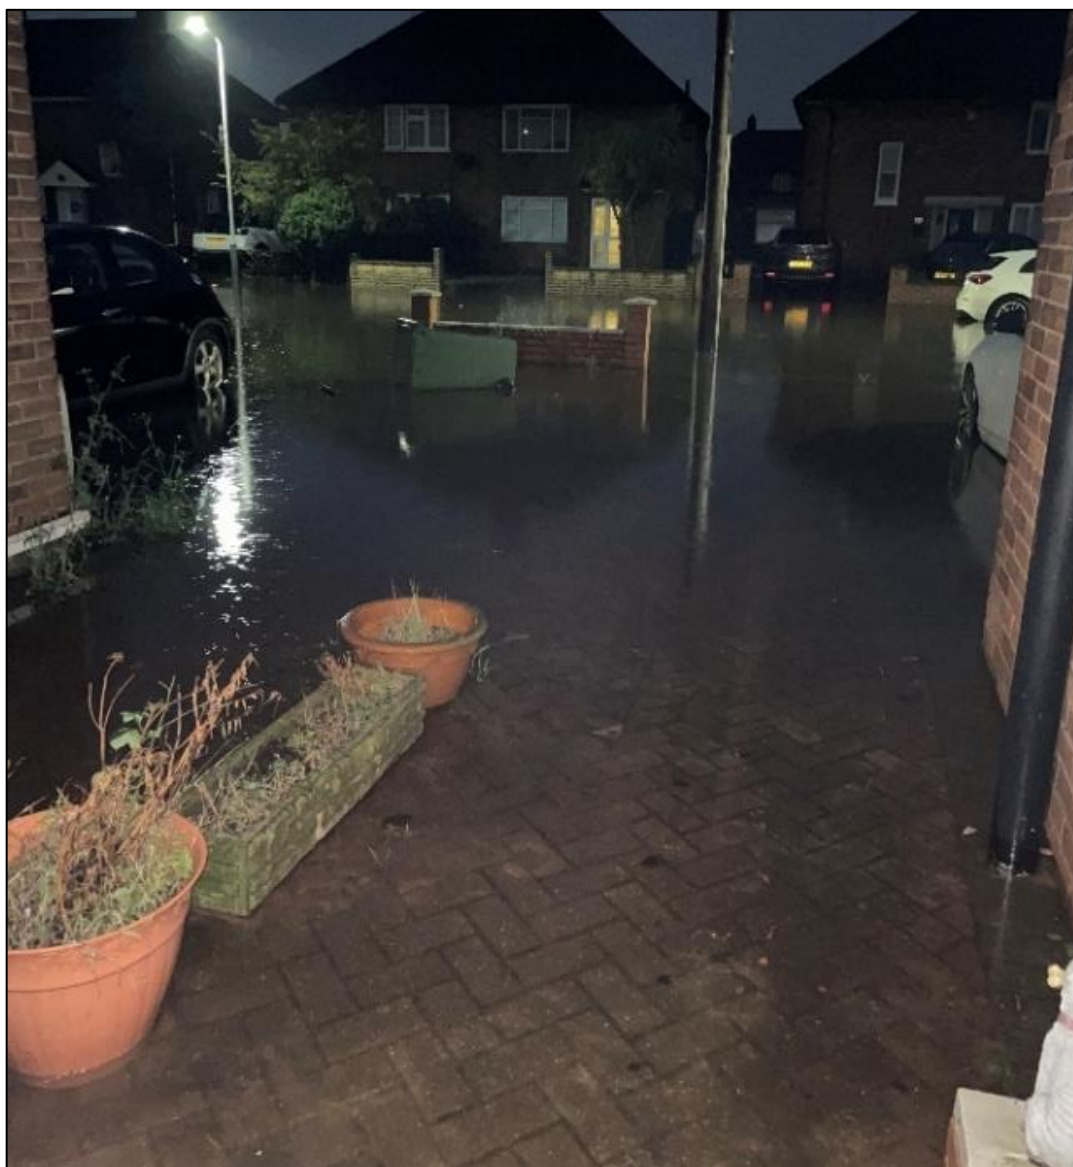
gullies requiring clearing before the flood event, which likely further reduced the amount of surface water able to drain and worsened the flooding.

Figure 10-5: Photograph of surface water flooding along Down Barns Road on the 23 September 2024. Image credit: Down Barns Road resident.

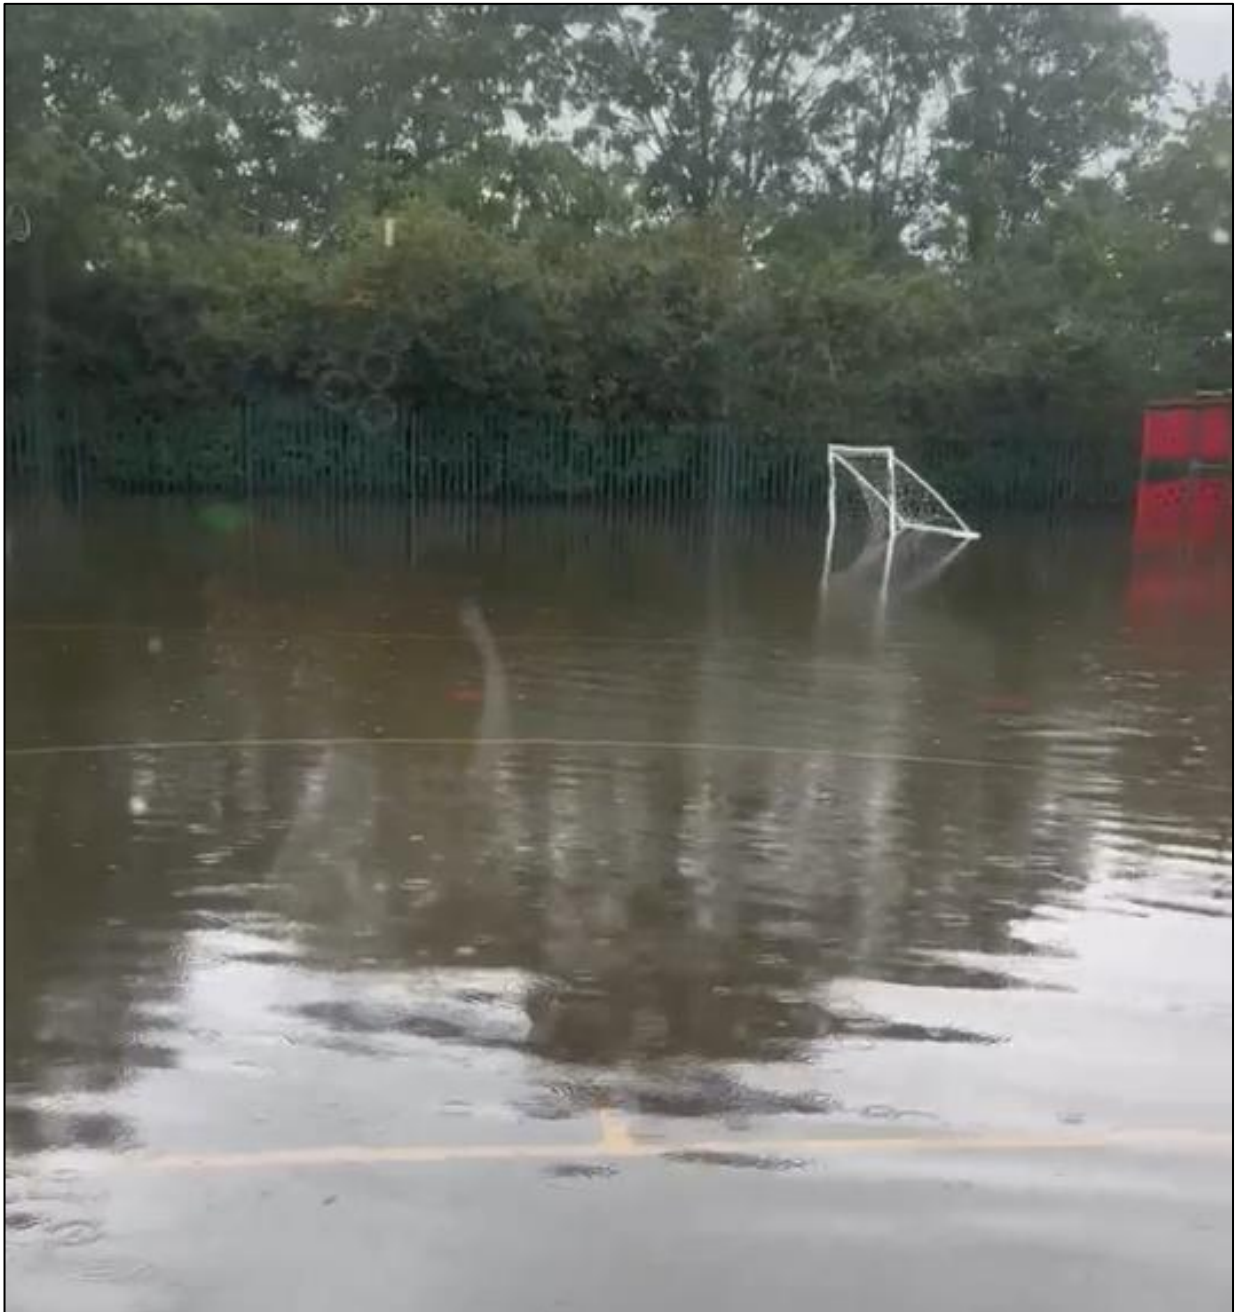
Figure 10-6. It is noted that the private drainage systems within the school grounds have had limited maintenance prior to the flooding event and thus may have contained blockages, worsening the surface water flooding. At Bourne Primary School, some of the flooding may have also been fluvial, as the Yeading Brook East reportedly overflowed its banks at this location. On a final note, the flooding at Bourne Primary School was contaminated with foul water, potentially indicating that a surface water sewer with a misconnection either surcharged near the school or discharged into the Yeading Brook East further upstream of the school.

Figure 10-6: Photograph of the flooding at Bourne Primary School on the 23 September 2024. Image credit: Bourne Primary School.

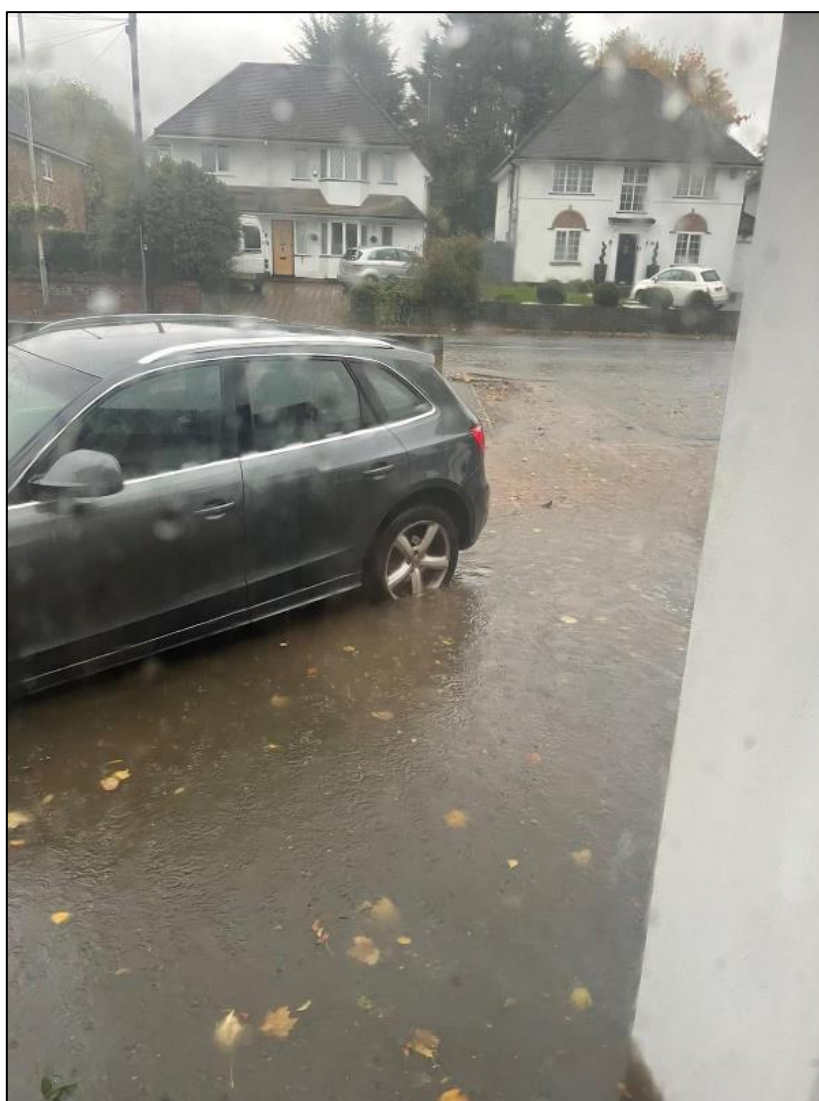
Figure 11-5: Photograph of surface water flooding at the front of an Eastcote Road property on the 23 September 2024. Image credit: Eastcote Road resident.

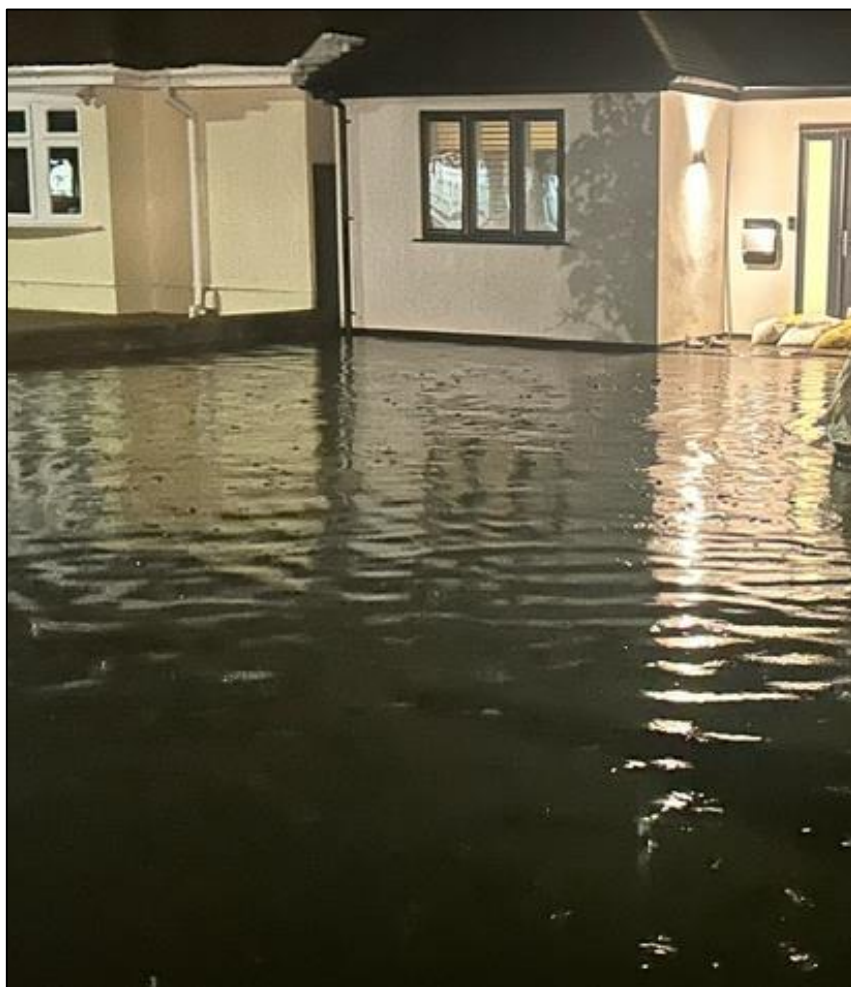
- 11.2.4 In 2016, Hillingdon Council installed a swale and a pond next to Brook Drive to help desynchronise peak surface water flows into the River Pinn and peak riverine flows from further upstream. However, a high-water table means that these features fill up with groundwater, which reduces their capacity and likely meant that they were unable to attenuate the surface water runoff on the 23 September. Additionally, the upstream flows were likely enough alone to cause the River Pinn to breach its banks at this location and cause fluvial flooding to Brook Drive, as shown in *Figure 11-6*. Due to previous fluvial flooding along Brook Drive, many of the properties have PFR measures installed. These proved effective on the 23 September in minimising the number of internal flooding incidents.

Figure 11-6: Photograph of fluvial flooding along Brook Drive on the 23 September 2024. Image credit: Brook Drive resident.
