FLOOD INVESTIGATION REPORT

July 28th 2014

HILLINGDON
LONDON

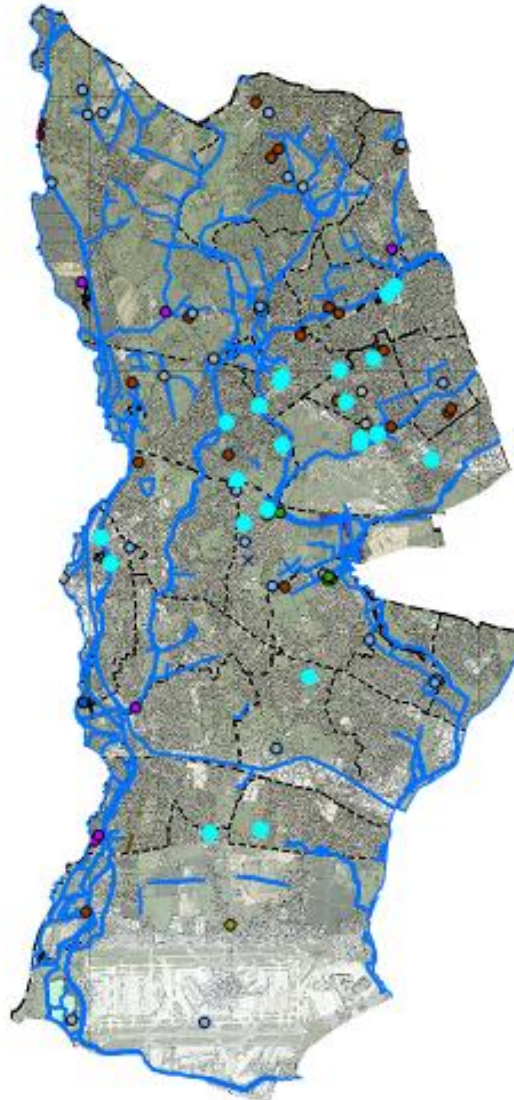
Map of Key areas affected on the 28th July.

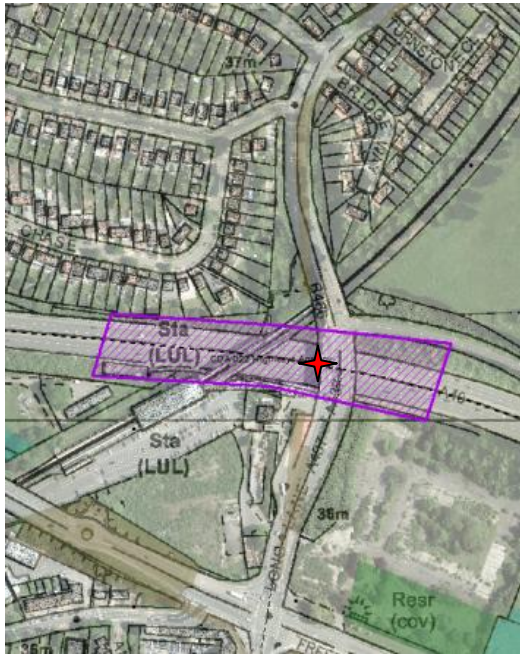
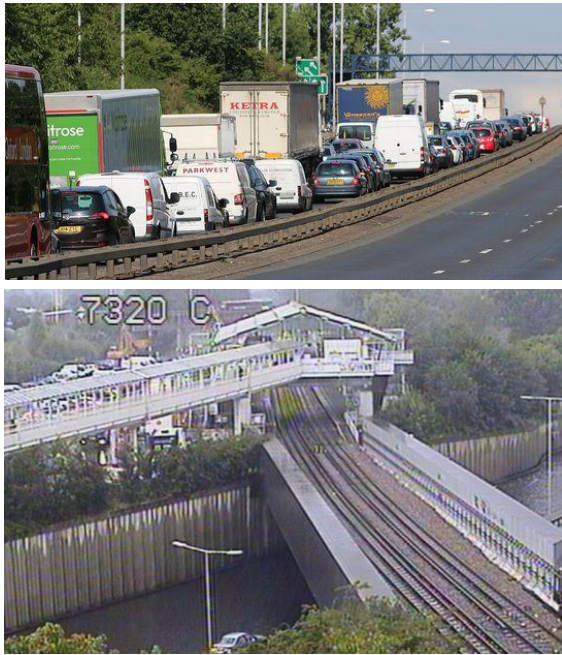
Area affected	a A40 adjacent to Hillingdon Underground Station	
Date of flooding	28/07/2014	
Grid Reference	507664 185051 TQ 0785SE	
Land ownership	TFL responsible	
Map of Area	Photo	
Location of flooding marked as a red star. Critical Drainage Area in purple	Tailback on A40 due to closure, Photo of water posted by Uxbridge South police team to twitter

Duration of flooding	Approximately 12 hours	
Source of flooding	Surface Water	
Cause/Pathway	Heavy rain in a very short period resulted in the overwhelming of surface water drainage arrangements and water built up in low point on the A40	
Impact of flooding	A40 closed, diversions and tailbacks across Hillingdon	
Evidence	Photographs from a variety of sources. The area is also defined as Critical Drainage Area, within the SWMP.	
History of flooding	None	
Summary	Identified as an area of risk within the Hillingdon Surface Water Management Plan (2011) and published on the Hillingdon website. A copy was provided to Transport for London 22 nd Jan 2013.

Action by TFL	Investigate and determine appropriate actions and share discuss with the Council as the Lead local Flood Authority	
Action by the Council	Further investigation has been undertaken by the Council working with the GLA and Drain London but no information on the drainage infrastructure in the area has been provided by TFL despite repeated information requests. The investigation undertaken by TFL has been requested by the Council on a number of occasions since the event but not yet provided.

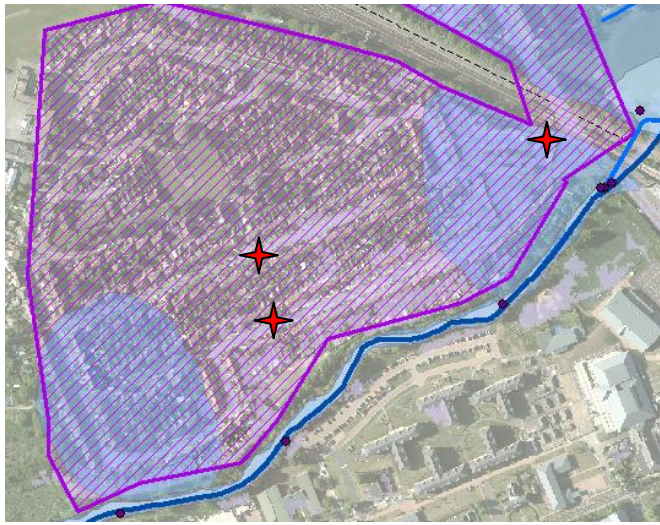
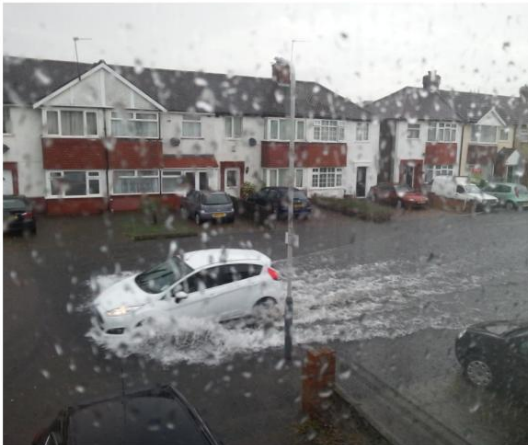
Area affected	b Bedford Road, Clyfford Road and West End Road HA4 6NA	
Date of flooding	28/07/2014	
Grid Reference	509876 185800	
Land ownership	LBH adopted roads and residents	
Map of Area	Photo	
Location of flooding marked as a red star. Blue indicates fluvial flooding and purple surface water taken from EA Flood Maps Red dots indicate Thames Water Surface water sewer outfalls	Taken by residents and provided in Environment Agency Flood Data recording report.

Duration of flooding	Approximately 3 hours	
Source of flooding	Surface Water	
Cause/Pathway	Overwhelming of surface water sewer, water building up in the low points in the roads and spilling out and over the footpaths and into front gardens. Water levels also built up rear of some properties.	
Impact of flooding	Flooding across access roads and in approximately 23 houses	
Evidence	Photos and anecdotal reports from the Get West London. The location is identified on the Environment Agency Flood Map as an area at risk from surface water and fluvial flooding. The area is also within a Critical Drainage Area.

History of flooding	None, although on West End Road there have been previous reports of flooding although more details are not known	
Summary	Heavy rain within a very short period of time overwhelmed the local drains. The London Fire Brigade (LFB) attended the scene on the 28 th July to assist residents. Sandbags provided by LFB to 20 -50 properties affected, some internally.	
Action by the Residents	The Council recommends that where appropriate residents identify what they can do to protect themselves. Products that may help such as air brick covers, with information about them and links to where they can be found on the internet are on the 'flooding' page on Hillingdon website.

<p>Additionally increasing the permeable areas will help reduce the water flowing towards the sewers. Any new front gardens which are paved should comply with GDPO requirements to ensure they are either permeable or drain to a permeable area within the garden.</p> <p>In addition there is concern by residents that the access road to the rear of the properties may be contributing to flooding. These roads are privately owned and the Council holds no information on their current drainage arrangements. Residents need to work together to ensure that the drainage arrangements are maintained by the owner.</p> <p>Every resident should report issues to Thames Water to ensure that the reports they receive reflect the severity of the situation, and the numbers truly affected.</p>
<p>Action by the Council</p>	<p>The Council are responsible for the gullies in an adopted Highway. The gullies are cleaned on a yearly basis by the Council, and are in this area scheduled to be cleaned in approximately August every year. The gullies were cleaned on 4th August 2014. A number of gullies were covered by parked cars and the Highways service returned at a later date to clear these.</p> <p>Where gullies are blocked the debris is removed and the gullies jetted with water to ensure the connections into the sewers are clear. It should be noted that, in heavy rain, leaves and other debris is washed into gullies, blocking them even if they had been previously clear prior to the flood event.</p> <p>The Council has invested in a new system to review the prioritisation of the gullies so that gully clearing could be more frequently to high priority sites less frequent in less critical areas.</p> <p>Council officers have also checked the Thames Water surface water outfalls and found water flow from them to be impeded by silt and vegetation and have reported it to Thames Water to investigate and take action.</p>

<p>Action by Thames Water</p>	<p>Thames Water are responsible for the surface water sewer that gullies drain into. Thames Water visited the site in August on request of residents and undertook a CCTV survey of the surface water sewer. However they were prevented from completing this because the line was blocked. Further work was commissioned by Thames Water for their contractors to undertake a line clean of the surface water sewer. Tree roots which had blocked the line were cut back. Thames Water has said they will monitor the situation and respond to future reports.</p> <p>The Council have requested that Thames Water investigate the whole length of surface water sewer to the point of discharge into a river so that it can be confirmed that the system functions appropriately.</p>
<p>Action by the Environment Agency</p>	<p>The Environment Agency sent out officers to record information on the flood. The council has been provided with the data collected.</p>

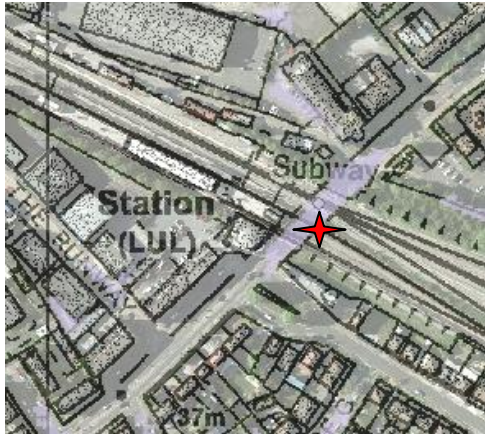
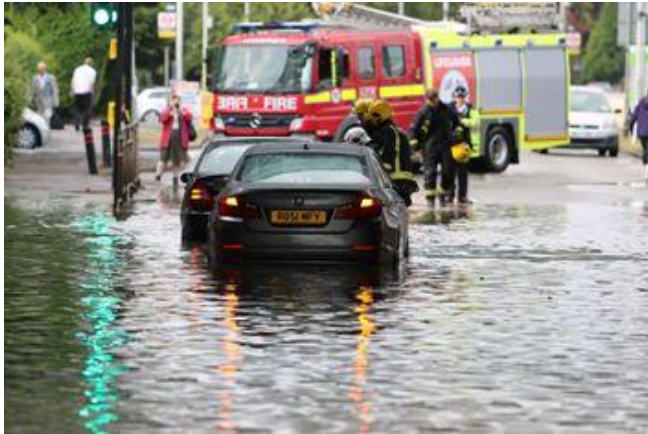
Area affected	c Station Approach, Ruislip HA4 6TP	
Date of flooding	28/07/2014	
Grid Reference	511149 185418	
Land ownership	LBH Adopted Highway	
Map of Area	Photo	
Location of flooding marked as a red star	Taken by Alan Palmer http://www.getwestlondon.co.uk/news/local-news/two-women-rescued-car-south-7518302

Duration of flooding	Approximately 3 hours	
Source of flooding	Surface Water	
Cause/Pathway	Overwhelming of surface water sewer	
Impact of flooding	Flooding of road and footpath. Two ladies required rescuing.	
Evidence	Reports from residents to the Council and news papers. The location is identified on the Environment Agency Flood Map as an area at risk from surface water.	
History of flooding	30/11/2009, 11/06/2012, 18/07/2012, 27/10/2013, 5/11/2013, 7/02/2014, 14/05/2014	
Summary	2 ladies rescued by LFB on the 28 th July after becoming stranded.	
Action by the Council	Council Highways services were called by residents and attended on the 28 th July. They used a tanker to remove water until approximately 4pm when Thames Water arrived. The Council team were able to point out the locations of the blockage. Gullies have been checked previously by the Council on a number of occasions and found to be clear. However a blockage in the surface water sewer was identified. It was reported to Thames Water on numerous occasions by the Council over the last few years, following resident's reports of other issues.

Action by Thames Water	Issue reported by the Council to Thames Water in October 2013. Thames Water have attended site on a number of occasions. Tree roots blocking the pipe were found. Works to clear this had still not been undertaken in July 2014. Road closure is required to enable the dig out of and replacement of the pipe work and replace it, as the blockage cannot be moved.

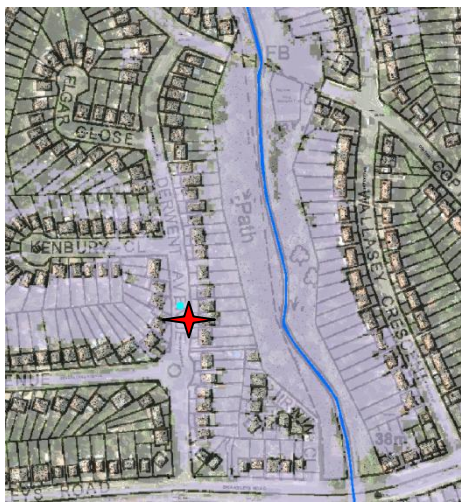
Area affected	d Derwent Avenue, Ickenham UB10 8HJ
Date of flooding	28/07/2014
Grid Reference	507208 186437
Land ownership	LBH adopted Highway
Map of Area	
Location of flooding marked as a red star	none

Duration of flooding	Approx 24 hours.
Source of flooding	Surface Water
Cause/Pathway	Overwhelming of surface water sewer
Impact of flooding	Road flooded, and one home flooded internally
Evidence	Anecdotal evidence from residents. The location is identified on Environment Agency Flood Map as an area where water at risk from surface water.
History of flooding	5 times in 2006, twice previously in 2014
Summary	Surface water flooding from overwhelming of the drains. The Thames Water network drains into the Ickenham stream at the end of Glebe Avenue.
Action by the Council	Gullies that the Council are responsible for are checked on a yearly basis. They have also been checked again following this incident and it was confirmed they are running clear.

Action by Resident	Resident advice to contact Thames Water to confirm there was no capacity issue

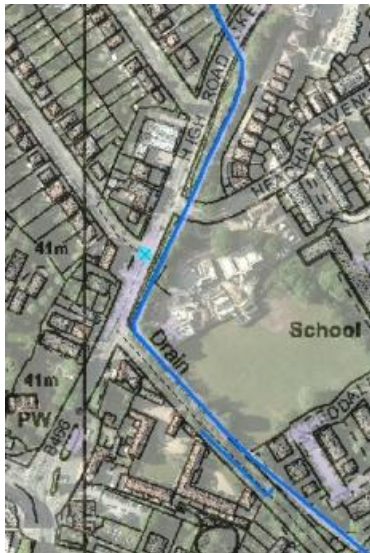
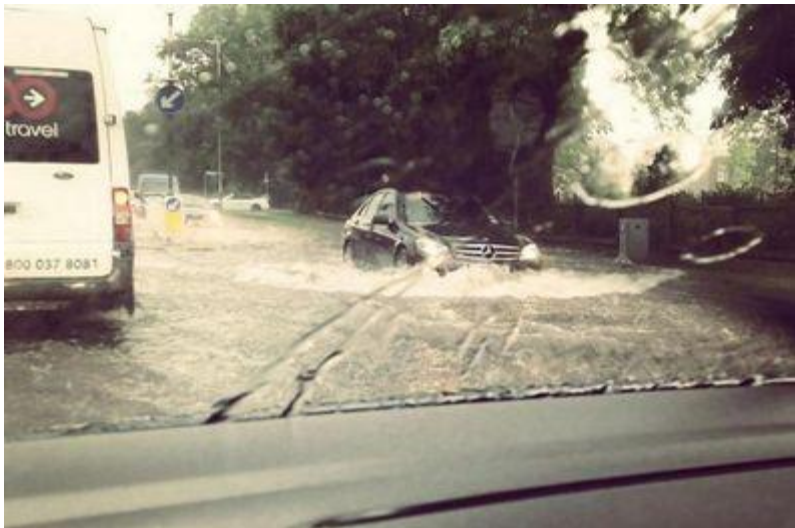
Area affected	e High Road and Austins Lane, Ickenham UB10 8RH	
Date of flooding	28/07/2014	
Grid Reference	508099 186245	
Land ownership	LBH adopted Highway and residents managed by private management company	
Map of Area		
Location of flooding marked as a red star	Photo from Get West London

Duration of flooding	Approx 24 hours.	
Source of flooding	Surface Water and Ordinary watercourse (unconfirmed)	
Cause/Pathway	Unconfirmed presumed to be water not draining away into the Ickenham stream	
Impact of flooding	Road flooded, almost flooding houses on Church Place and Tweedale Grove	
Evidence	Anecdotal evidence from residents. The location is identified on the Environment Agency Flood Map as an area at risk from surface water.	
History of flooding	none	
Summary	Residents tried to report issue to the Council but could not get through, to anyone after a couple of minutes.	
Action by the Council	To investigate maintenance regime of landowner of ordinary watercourse

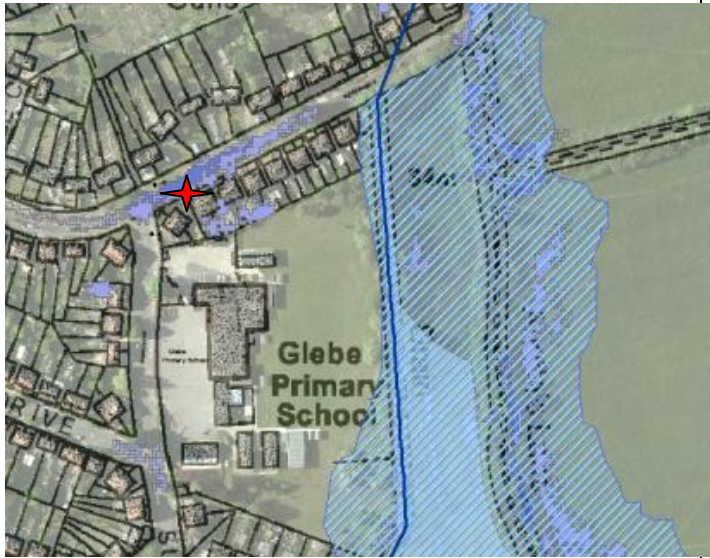
Area affected	f Glebe Avenue, Ickenham UB10 8PQ
Date of flooding	28/07/2014
Grid Reference	508480 185679
Land ownership	Adopted Highway
Map of Area	
Location of flooding marked as a red star

Duration of flooding	Approximately 3 hours
Source of flooding	Surface Water
Cause/Pathway	Highway
Impact of flooding	Flood water flowed across road and into 4 households.
Evidence	Photos and correspondence from residents
History of flooding	1975, 1976 unverified, 1977 flood water entered homes, 1978, 1993, 2006 foul water entered gardens and garages, 2014 flood water entered homes. Identified on the Environment Agency Flood Map for Surface Water as a low lying area.
Summary	Surface water flooding from the overwhelming of the drains, which also caused issues with foul network. The Thames Water network drains into the Ickenham stream at the end of Glebe Avenue.
Action by the Council	<p>Council officers have raised the following issues with other bodies:</p> <ul style="list-style-type: none"> • The need for ongoing maintenance by Thames Water on the surface water sewer main • Maintenance of the Ickenham Stream by the Environment Agency. • The Council have also requested the Environment Agency review their river level monitoring and flood warnings within Hillingdon to see if areas currently not covered can be provided with a warning.

<p>The Council has undertaken the following:</p> <ul style="list-style-type: none"> • Gullies are cleared on an annual basis. • The clearance of the Ickenham stream by contractors has been prioritised to ensure it is flowing properly. Work is scheduled for November/ December 2014.
Action by residents	<p>Ickenham Residents Association are collecting information on future flood events and mapping them and providing that to the Council.</p> <p>The Council recommend that residents draw up a Flood Plan. Further information about this can be found on the Hillingdon website. Also on products to protect houses from flooding through airbricks</p>
Action by Thames Water	<p>Thames Water have attended site since the event on a number of occasions. In November 14 is Glebe Avenue was partially cleared However manhole covers were jammed, so work is proposed to free them.</p>
Action by the Environment Agency	<p>The Environment Agency is funded by DEFRA to undertake maintenance on main rivers. This is focused on high priority areas, and the Environment Agency has advised that, because the Ickenham stream is not at risk from main river flooding, it is not proposed for maintenance by the Environment Agency.</p> <p>No flood warning is issued for the Ickenham Stream.</p>

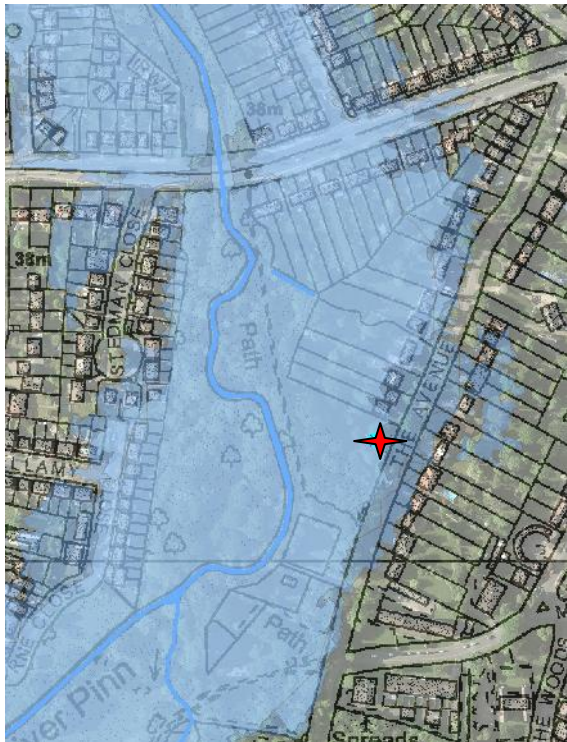
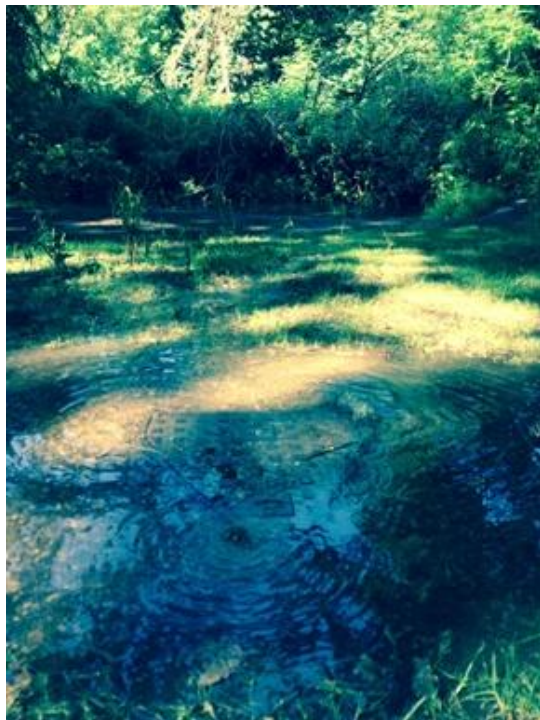
Area affected	g The Avenue, Ickenham UB10 8NR	
Date of flooding	28/07/2014	
Grid Reference	507473 186082	
Land ownership	Residents.	
Map of Area	Photo	
Location of flooding marked as a red star	28 th July 2014 Taken by resident

Duration of flooding	Approximately 3 hours	
Source of flooding	Foul Water	
Cause/Pathway	Unconfirmed	
Impact of flooding	A number of garages and the highway	
Evidence	Anecdotal evidence from the Council and residents.	
History of flooding	none	
Summary	Reports from residents regarding the foul sewer flowing into the River Pinn.	
Action by Thames Water	Reported to Thames Water by residents Reference 0081/03SGWZ. CCTV survey shows fractures in the pipe which needs to be resolved. Works ongoing.

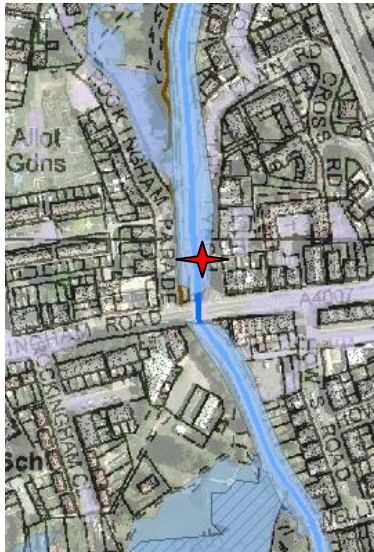
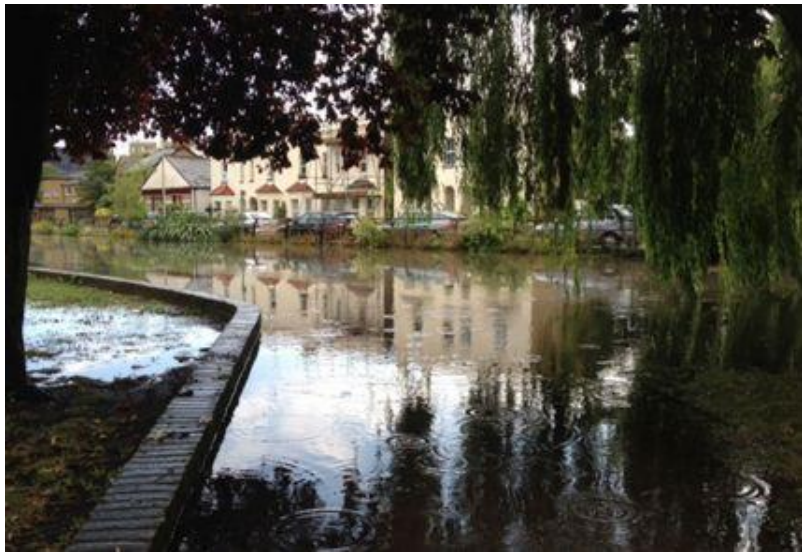
Area affected	h Rockingham Parade and The Lynch, Uxbridge UB82TQ	
Date of flooding	28/07/2014	
Grid Reference	505379 183540	
Land ownership	Adopted Highway	
Map of Area	Photo	
Location of flooding marked as a red star. Blue indicates fluvial flooding shown on Flood Zones	Taken by Steve Terrill GET West London http://www.getwestlondon.co.uk/news/local-news/in-pictures-flooding-hits-hillingdon-7518585

Duration of flooding	Approximately 3 hours	
Source of flooding	River Colne	
Cause/Pathway	The River Colne water levels rose due to the amount of rain falling, and a Flood Alert was issued for the area by the Environment Agency at 10:43am	
Impact of flooding	Flood water flowed across the road and into front gardens. Unverified reports of flooding through airbricks.	
Evidence	Photos and reports from residents	
History of flooding	None, but identified as being within an area at risk of fluvial flooding on the Environment Agency Flood Map.

Summary	River levels were high	
Action by the Council	Continued monitoring of the situation	
Action by the residents	The Council recommend residents draw up a Flood Plan. Further information can be found on the Hillingdon website. Also on products that can be purchased to protect homes from flooding through airbricks.

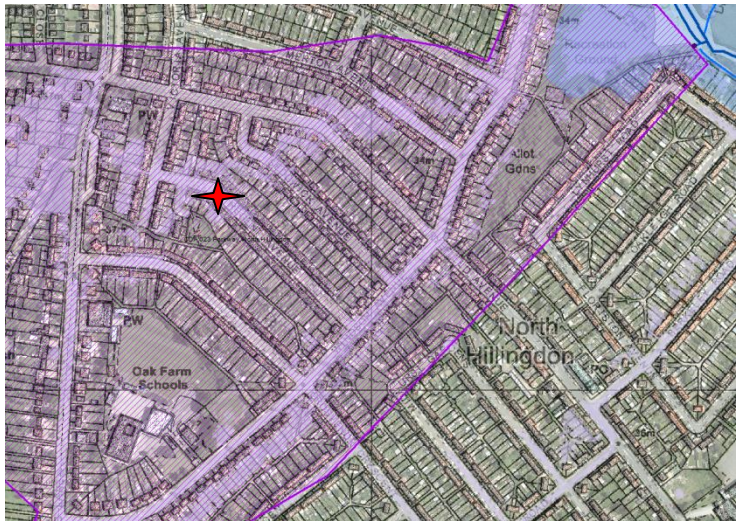
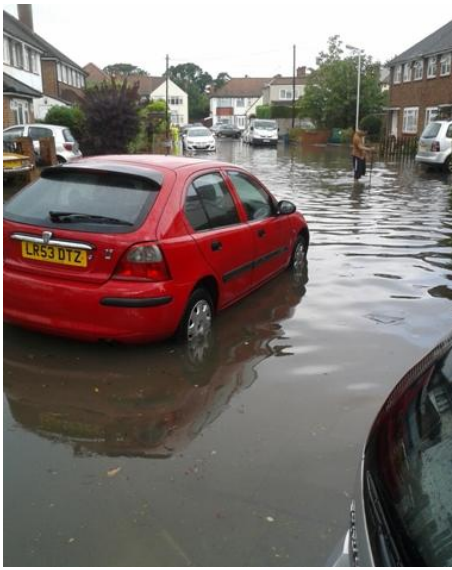
Area affected	i Regents Avenue and Windsor Avenue Uxbridge UB10 9AT	
Date of flooding	28/07/2014	
Grid Reference	508193 184513	
Land ownership	Adopted Highway	
Map of Area	Photo	
Location of flooding marked as a red star, purple hatching defines the critical drainage area, with shaded purple the areas likely to be at risk from surface water	Taken by resident

Duration of flooding	Approximately 3 hours	
Source of flooding	Surface Water	
Cause/Pathway	Water built up in the road flowing over footpaths into front gardens and into some homes.	
Impact of flooding	Flood water flowed across the road and into front gardens and in some cases; this resulted in houses being flooded internally.	
Evidence	Photos and reports from residents. The area is also within a Critical Drainage Area identified by the SWMP	
History of flooding	None, but identified as within an area at risk of surface water flooding on the Environment Agency Flood Map.

Summary	Flood water built up and flowed into houses very quickly	
Action by the Council	To record the event, and refer to Thames Water	
Action by the residents	The Council recommend residents draw up a Flood Plan. Further information can be found on the Hillingdon website. Also on products that can be purchased to protect homes from flooding through airbricks.

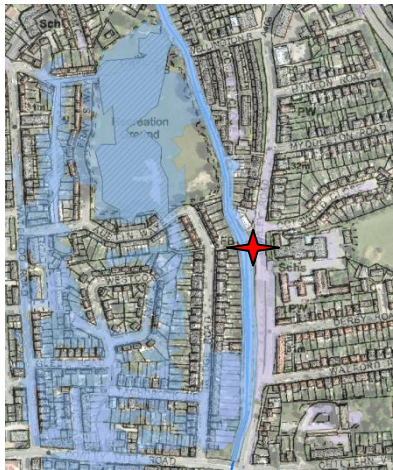
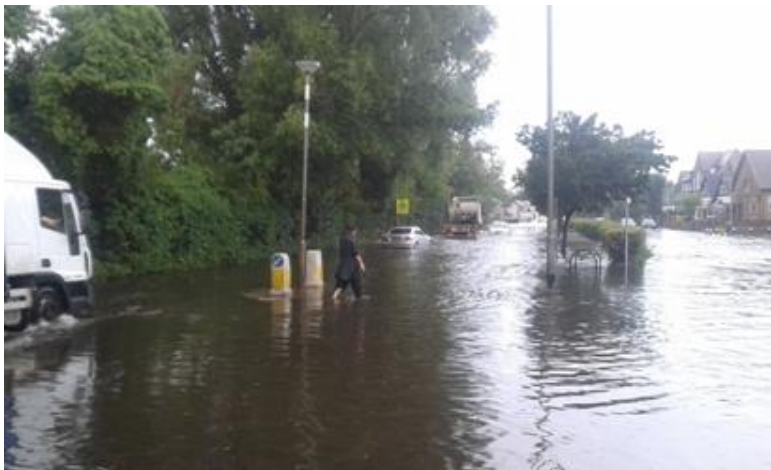
Area affected	j Cowley Road, Uxbridge UB8 2LT	
Date of flooding	28/07/2014	
Grid Reference	505376 183544	
Land ownership	Adopted Highway	
Map of Area	Photo	
Location of flooding marked as a red star	Taken by London Borough of Hillingdon Officer

Duration of flooding	Approximately 3 hours	
Source of flooding	Surface Water	
Cause/Pathway	Overwhelming of surface water sewer by heavy rain.	
Impact of flooding	Cowley Road closed to buses, with tailbacks and diversions	
Evidence	<p>Cowley Road Uxbridge 28th July 2014 - YouTube</p> <p>▶ 0:27 ▶ 0:27</p> <p>www.youtube.com/watch?v=DHOWfN27zY0</p> <p>1 day ago - Uploaded by Nigel Clark</p> <p>Uxbridge Cowley Road flood rain</p>	
History of flooding	None, but identified as being within an area at risk of surface water flooding on the Environment Agency Flood Map.	
Summary	Lower River Colne and Fray's River. Flood Alert issued by the Environment Agency. The River Colne rose above the level of Thames Water pipes discharging water from the road into the river. This meant that water could not drain away quickly, so that it built up in the road until the water level in the river fell again.

Action by the Council	Gullies checked to ensure they are clear.

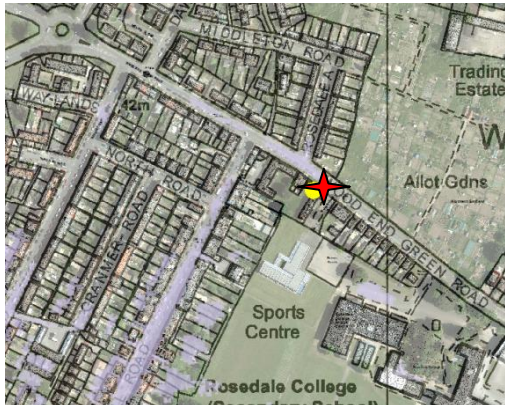
Area affected	k Wood End Green Road UB3 2SF	
Date of flooding	28/07/2014	
Grid Reference	508946 181496	
Land ownership	Adopted Highway	
Map of Area	Photo	
Location of flooding marked as a red star	none

Duration of flooding	Approximately 3 hours	
Source of flooding	Surface Water	
Cause/Pathway	Water built up in the road flowing over footpaths into front gardens	
Impact of flooding	Flooding of the road	
Evidence	Reports from residents	
History of flooding	Consistently reoccurring issue 23/11/2014, 04/11/2014, 19/08/2014 28/07/2014. Identified as an area at risk of surface water flooding on the Environment Agency Flood Map.	
Summary	Flood water built up very quickly	
Action by the Council	To continue yearly clearance of gullies. Gullies last checked on the 8 th October 2014. To continue raising the issue with Thames Water. To provide residents with information on how to dispose of fats and grease - This can be found on the Hillingdon website.

Action by Thames Water	Thames Water have attended site on a number of occasions to clear both the foul and surface water sewer. Thames Water to send out literature on the proper disposal of fats and grease as this had blocked the foul sewer.	
Action by the residents	To dispose of fats and grease appropriately. The Council recommend residents draw up a Flood Plan. Further information can be found on the Hillingdon website. Also on products that can be purchased to protect homes from flooding through airbricks. To continue to report all issues to Thames Water.

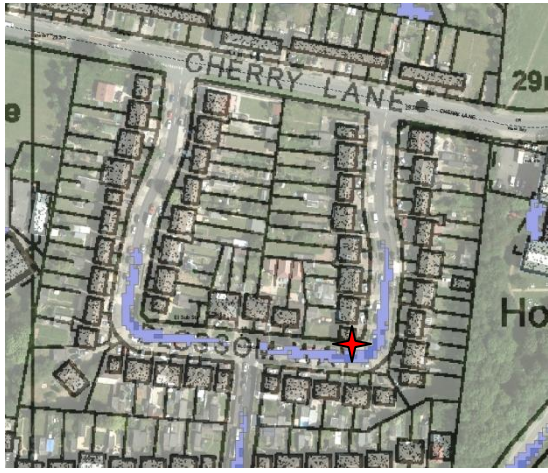
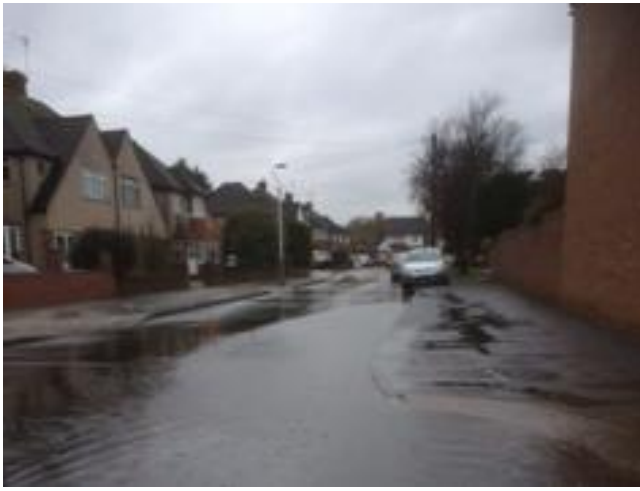
Area affected	I Blossom Way, West Drayton UB7 9HG	
Date of flooding	28/07/2014	
Grid Reference	507162 178683	
Land ownership	LBH Adopted Road	
Map of Area	Photo	
Location of flooding marked as a red star	Photo taken by resident and sent to the Council

Duration of flooding	Approximately 3 hours	
Source of flooding	Surface Water	
Cause/Pathway	Highway	
Impact of flooding	Road flooded for a number of hours	
Evidence	Photos and correspondence with residents	
History of flooding	Flooding reported by residents in Jan 2014. The area is also identified within an area at risk of surface water flooding on the Environment Agency Flood Map for Surface Water.	
Summary	Water ponding on the road was not able to drain away into the soakaways as they were full. A recurring issue.	
Action by the Council	There are no Thames Water surface water sewers in this road. All the drainage currently goes to a soak away in the verge. The Council considered a number of options and has created a new soak away to reduce the extent of flooding. However it should be noted there will be more extreme events which may overwhelm this system.
