Section 19 Flood Investigation

23 September 2024 Flood Event

HILLINGDON
LONDON

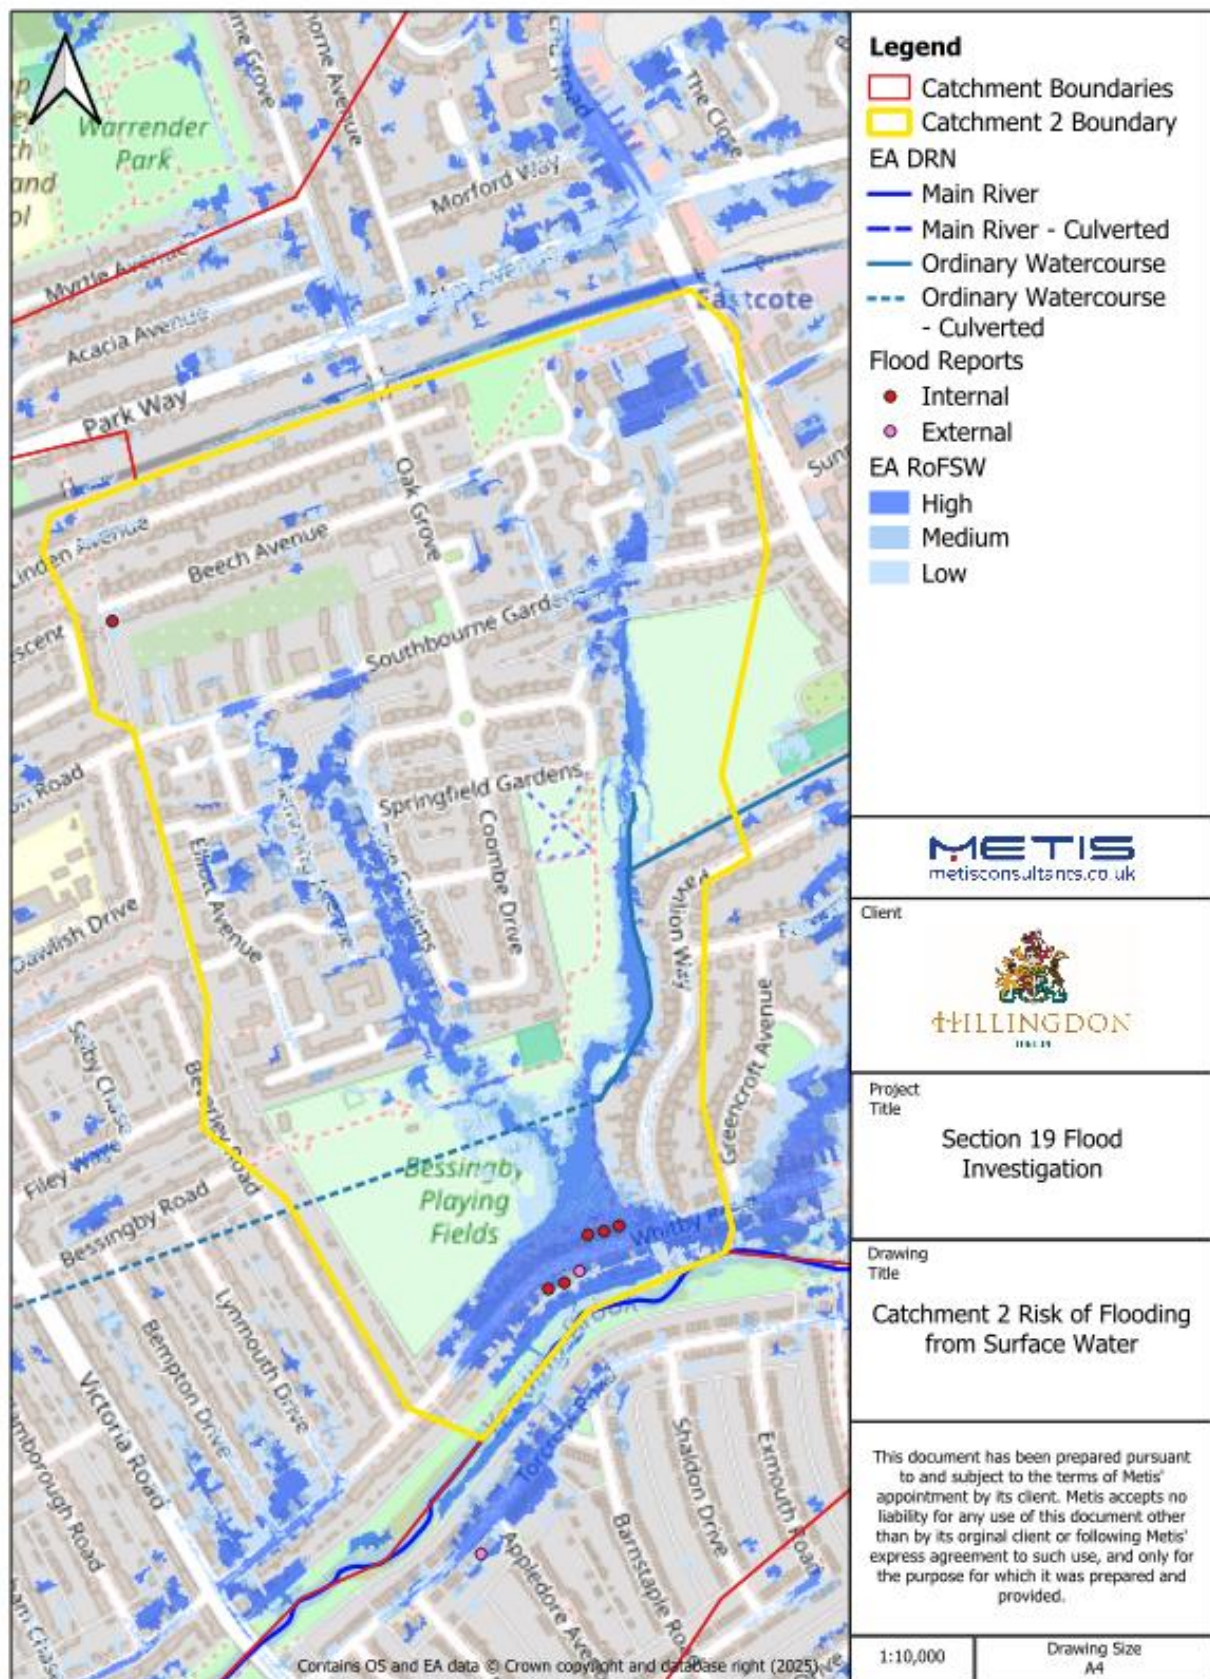
Figure 5-2: Catchment 2 flood incidents and Risk of surface water flooding.

- 5.1.2 As shown in Figure 5-2, there are two major surface water flow paths that run from the north of the catchment through Bessingby Park towards the Yeading Brook West in the south of the catchment. At Whitby Road, they converge with a third major flow path which originates from Catchment 3 to the east. The result is an elevated risk of surface water flooding along Whitby Road.

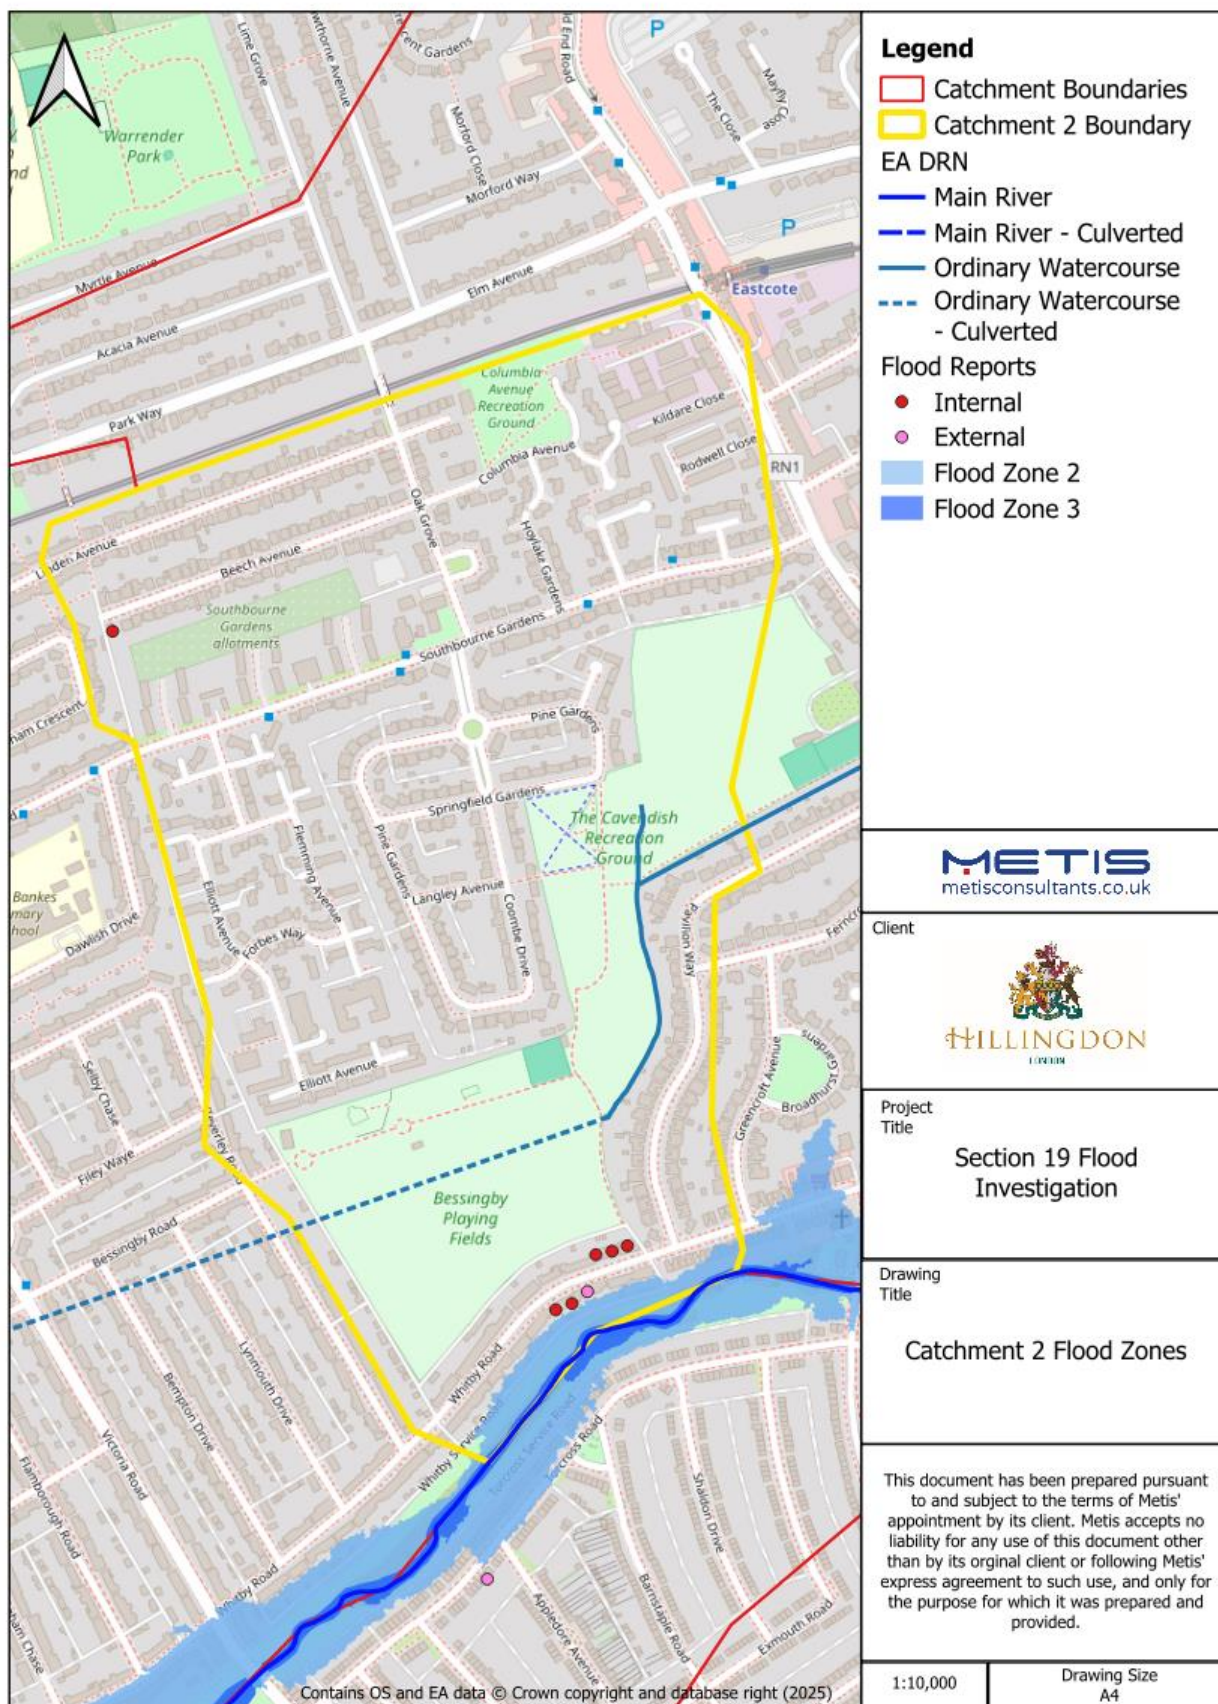
Figure 5-3: Catchment 2 flood incidents and Flood Zones.

- 5.1.3 As seen in Figure 5-3, some Whitby Road properties in the south-eastern extent of the catchment are located within Flood Zone 2. However, all the reported flood incidents are located within Flood Zone 1.
- 5.1.4 Although located within Flood Zone 1 and 2, some properties reported internal flooding from the river. On investigation there is a slight trench that leads to the properties north of the Yeading Brook West which operates as a flow channel. This has been identified for further investigation and remedial action.

- 5.1.5 Figure 5-3 shows that there is an ordinary watercourse which runs through Catchment 2. It is an open channel along the eastern boundary of Bessingby Park but becomes culverted as it crosses the green space. One of the major surface water flow paths follows the route of the open section of the ordinary watercourse. However, the flow path diverts from this route when the ordinary watercourse becomes culverted, potentially indicating that the capacity of the culvert can only deal with low-intensity rainfall events.

- Lead Local Flood Authority officers should investigate options for further flood alleviation works in Bessingby Park and bid for future funding opportunities should a feasible option be identified.

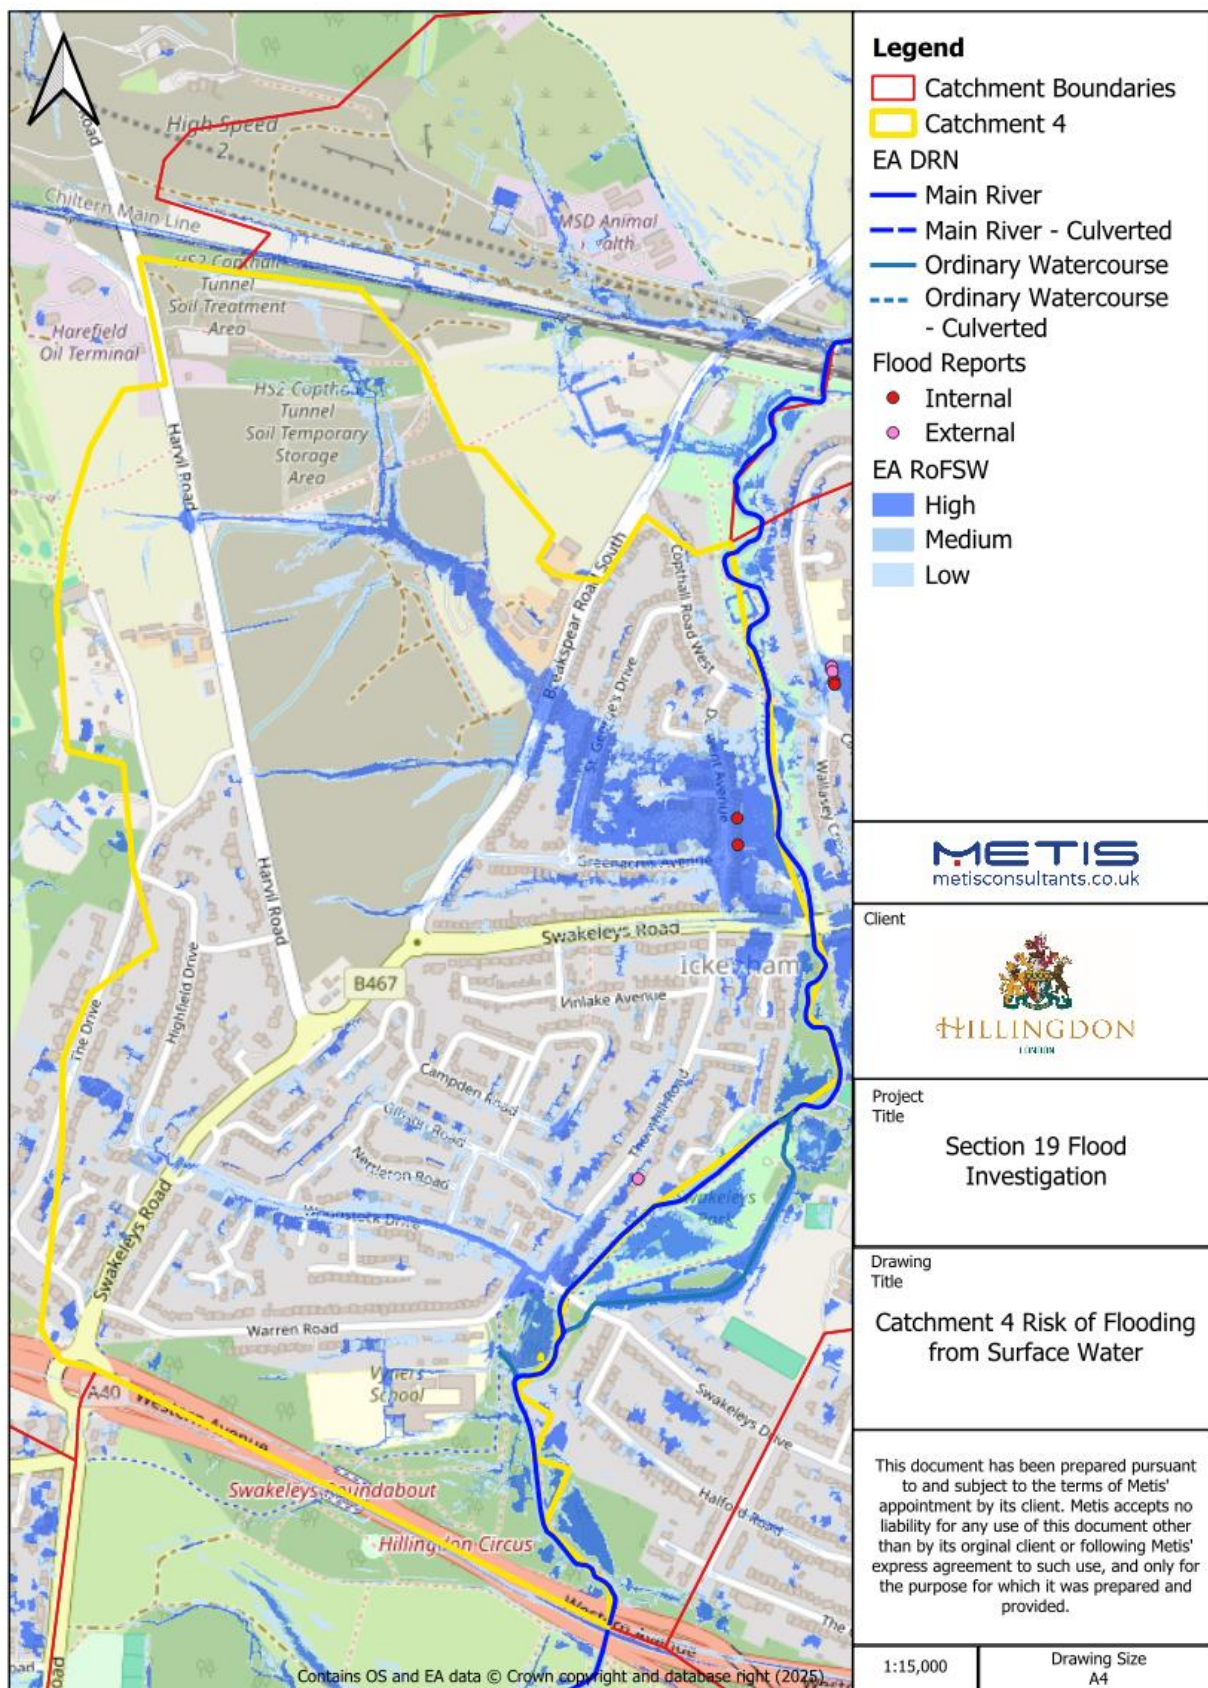
Figure 6-2: Catchment 4 flood incidents and Risk of surface water flooding.

- 6.1.2 As shown in figure 6-2, there is one major surface water flow path that runs from the HS2 development in the north-west of the catchment towards the River Pinn in the east of the catchment. Residential properties located between the HS2 project, and the River Pinn are at a high risk of surface water flooding.

- Flood-affected residents should consider installing PFR measures to reduce the amount of floodwater entering their property during a flood event. The National Flood Forum has a [six-step guide](#) to navigate the process of installing PFR measures.
- Hillingdon Council should continue to review HS2 plans, ensuring that the development does not increase the risk of flooding to surrounding properties.

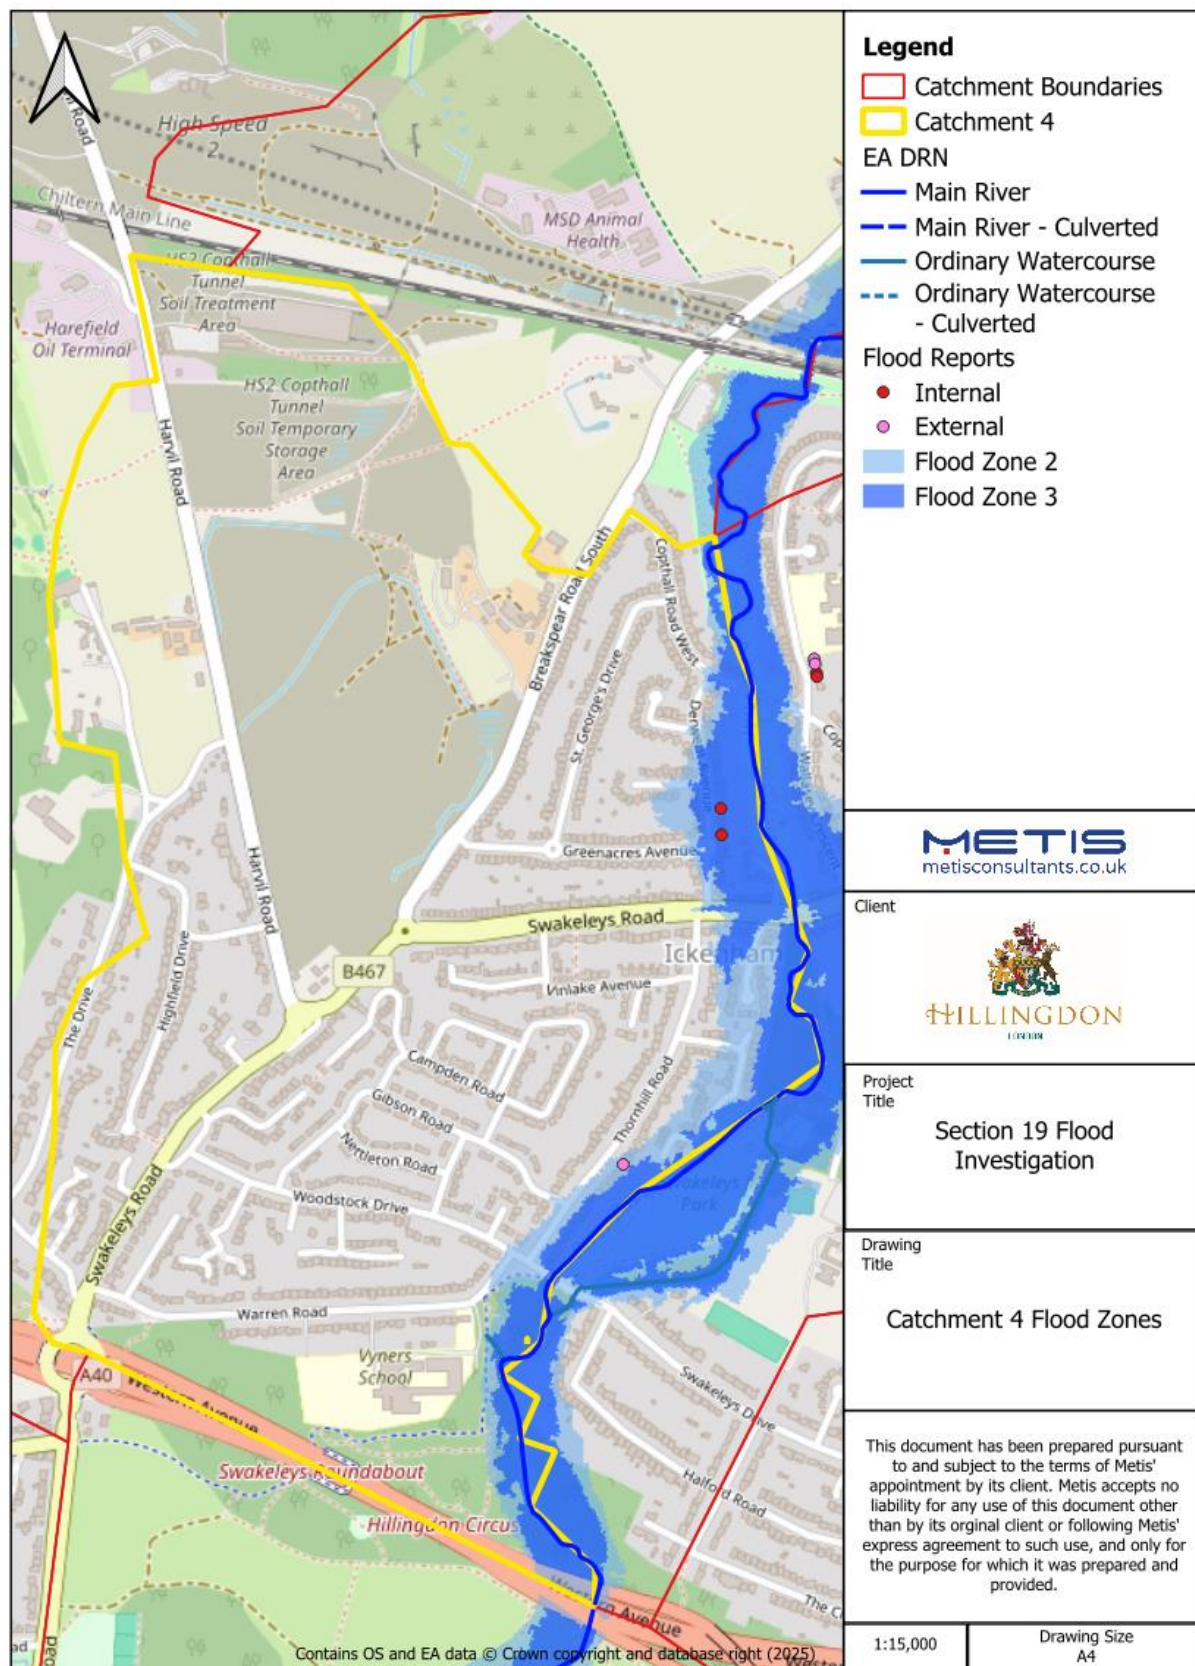
Figure 6-3: Catchment 4 flood incidents and Flood Zones.

- 6.1.3 As seen in figure 6-3, the EA's Flood Zone mapping shows that Flood Zone 3 extends over Derwent Avenue, Kenbury Close, Greenacres Avenue, and Copthall Road West.

- 6.2.3 The levels in the River Pinn reportedly continued to rise until it burst its banks into St George's Field. Derwent Avenue properties back onto St George's Field. As predicted by the EA's Flood Zone mapping, it was reported that the fluvial flooding extended far enough to cause additional water to enter some of these properties through low-lying back doors and airbricks.

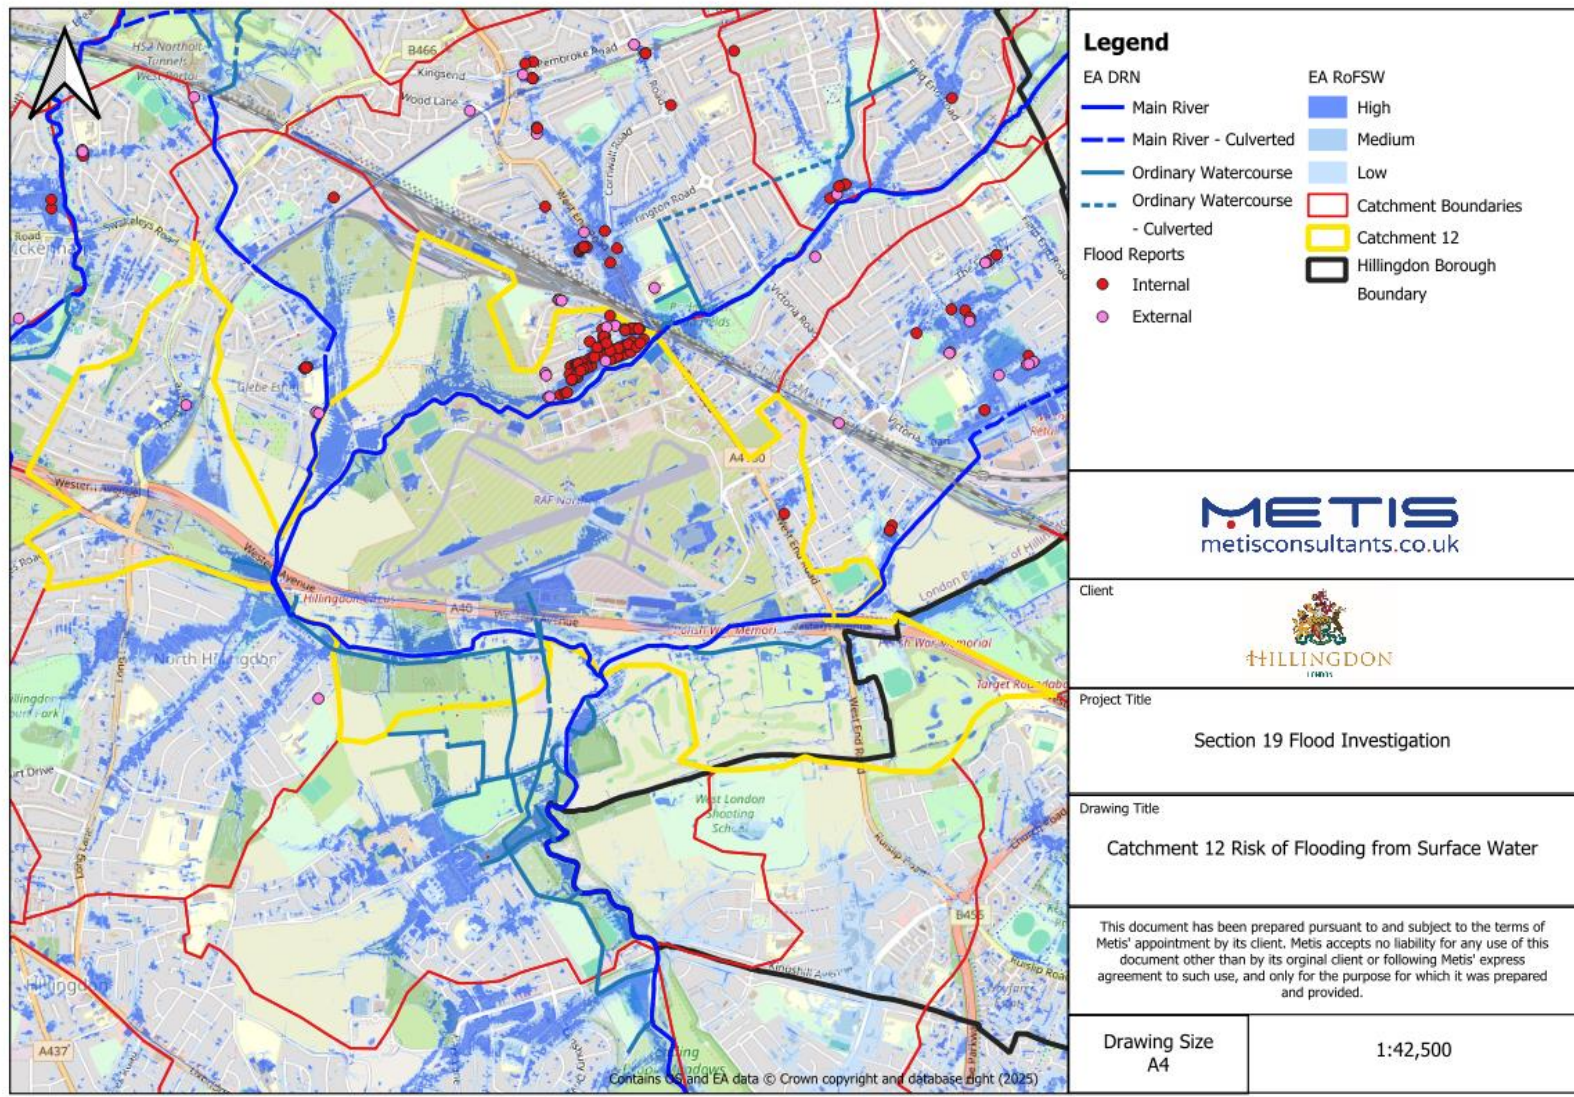
Figure 9-2: Catchment 12 flood incidents and Risk of surface water flooding.

- 9.1.3 As shown in figure 9-2 there is a major surface water flow path that follows the route of the Yeading Brook West from Ruislip Gardens Station towards the confluence with Ickenham Stream. There is also a high predicted risk of surface water flooding across much of RAF Northolt and along the A40.

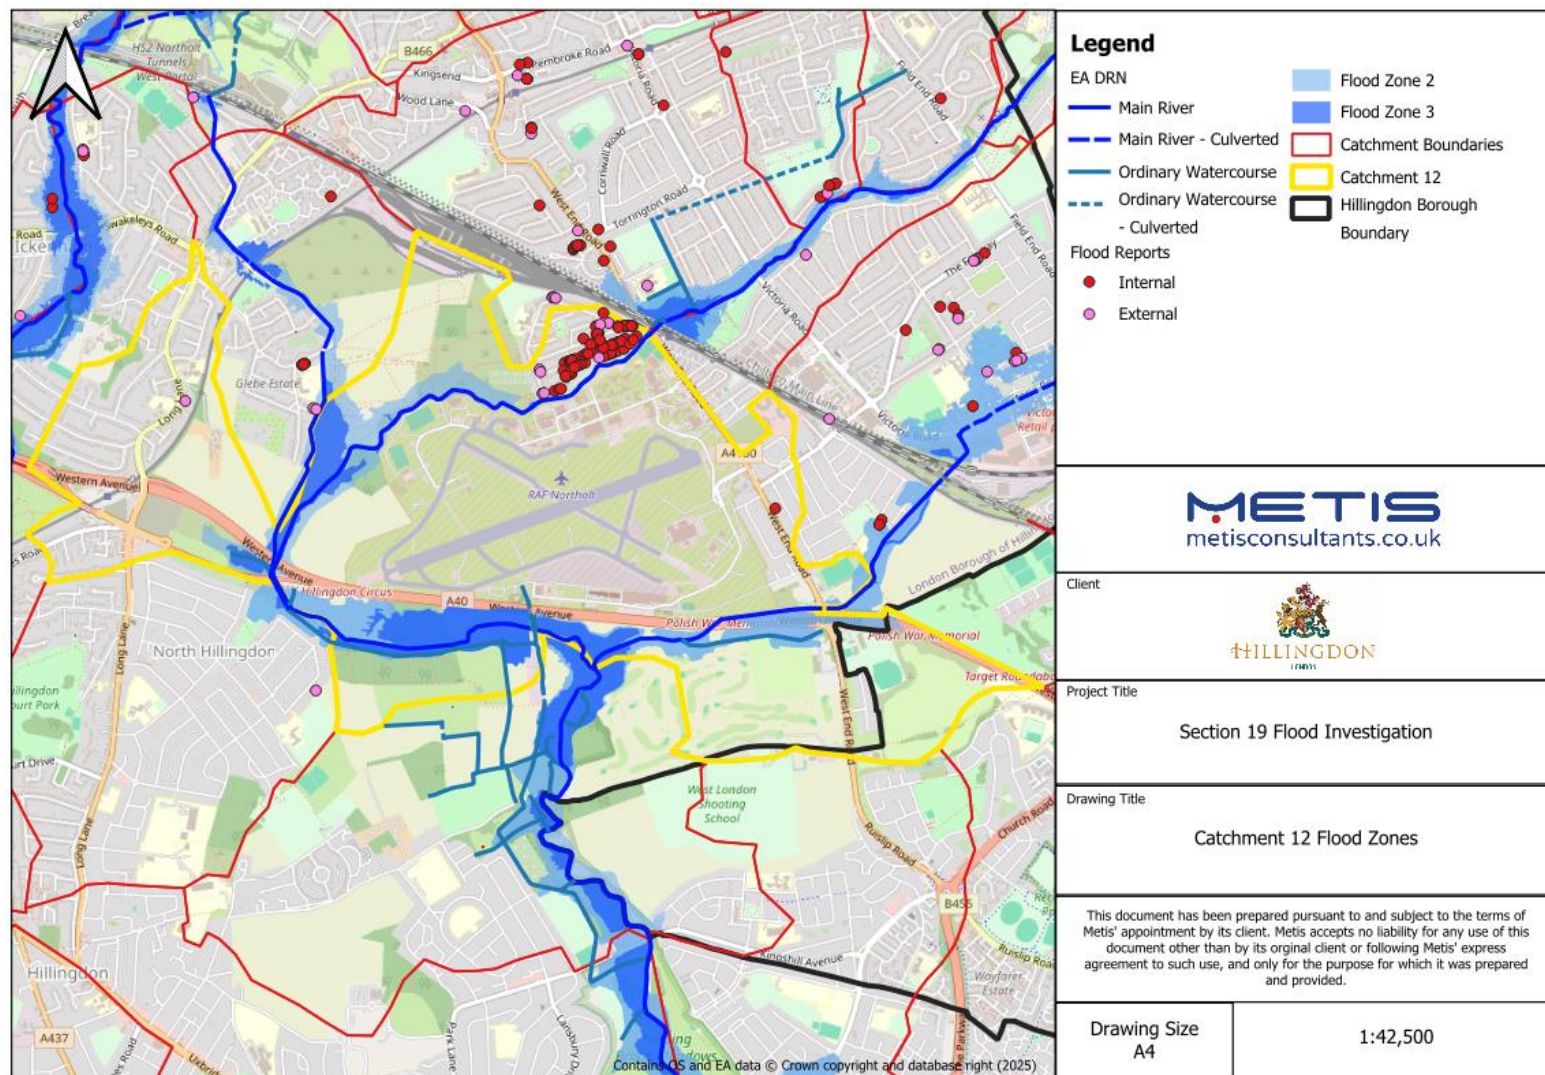
Figure 9-3: Catchment 12 flood incidents and Flood Zones.

- 9.1.4 As seen in figure 9-3, a large area of Ickenham Marsh surrounding the Yeading Brook West and Ickenham Stream lies within Flood Zone 2 and 3. A section of Gutteridge Wood and Meadows between the A40 and Yeading Brook West also lies in Flood Zone 2 and 3. C & L Golf and Country Club lies in Flood Zone 2 of the Yeading Brook East, as does a section of the A40. However, none of the flood incidents are located within Flood Zone 2 or 3.

- 9.1.5 Figure 9-3 also shows that there are a number of ordinary watercourses located in Gutteridge Wood and Meadows and in C & L Country and Golf Club. There are no ordinary watercourses located near or upstream of any reported flood incidents.

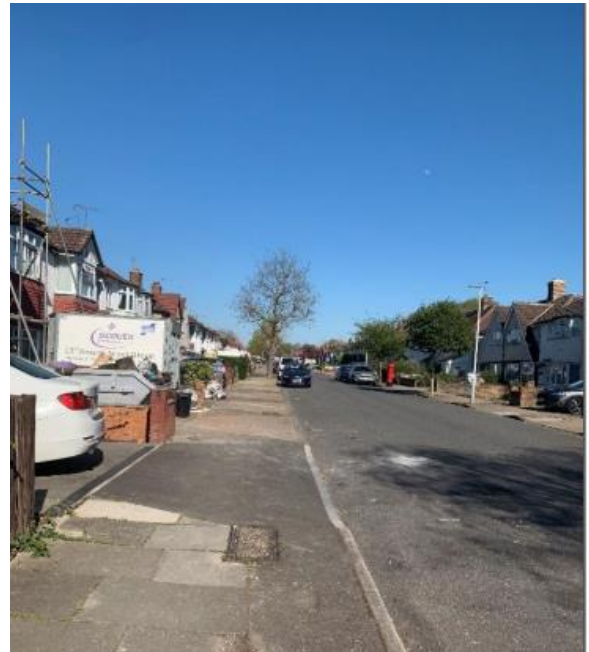
9.2.2 Additionally, it is noted that the gullies along these roads are not closely spaced typically serve upward of 20 properties each. For example, there are no gullies between 12 and 66 Clyfford Road, a length of 24 properties. As detailed in section 3, river levels in the Yeading Brook West rose which likely submerged the outfalls from the Thames Water drainage network.

9.2.3 It is necessary to note that the outfalls are particularly low within the Yeading Brook West (see image right). Whilst the river, as reported by residents, was far from 'full', it is the height of the outfalls that are material to the cause of flooding. The outfalls become less able to function as the water level rises; eventually the force of flow from the outfall into the river is not sufficient and the network becomes locked and backs up. This is evidenced by the flood risk mapping that shows Clyfford Road not at risk from river flooding even in the extreme 1:1000-year event, whilst being at risk from surface water flooding in much lower events (e.g. 1:30 year).

- Lead Local Flood Authority officers should continue to work in partnership with the EA and TWUL to develop the Ruislip Gardens flood alleviation scheme towards implementation.

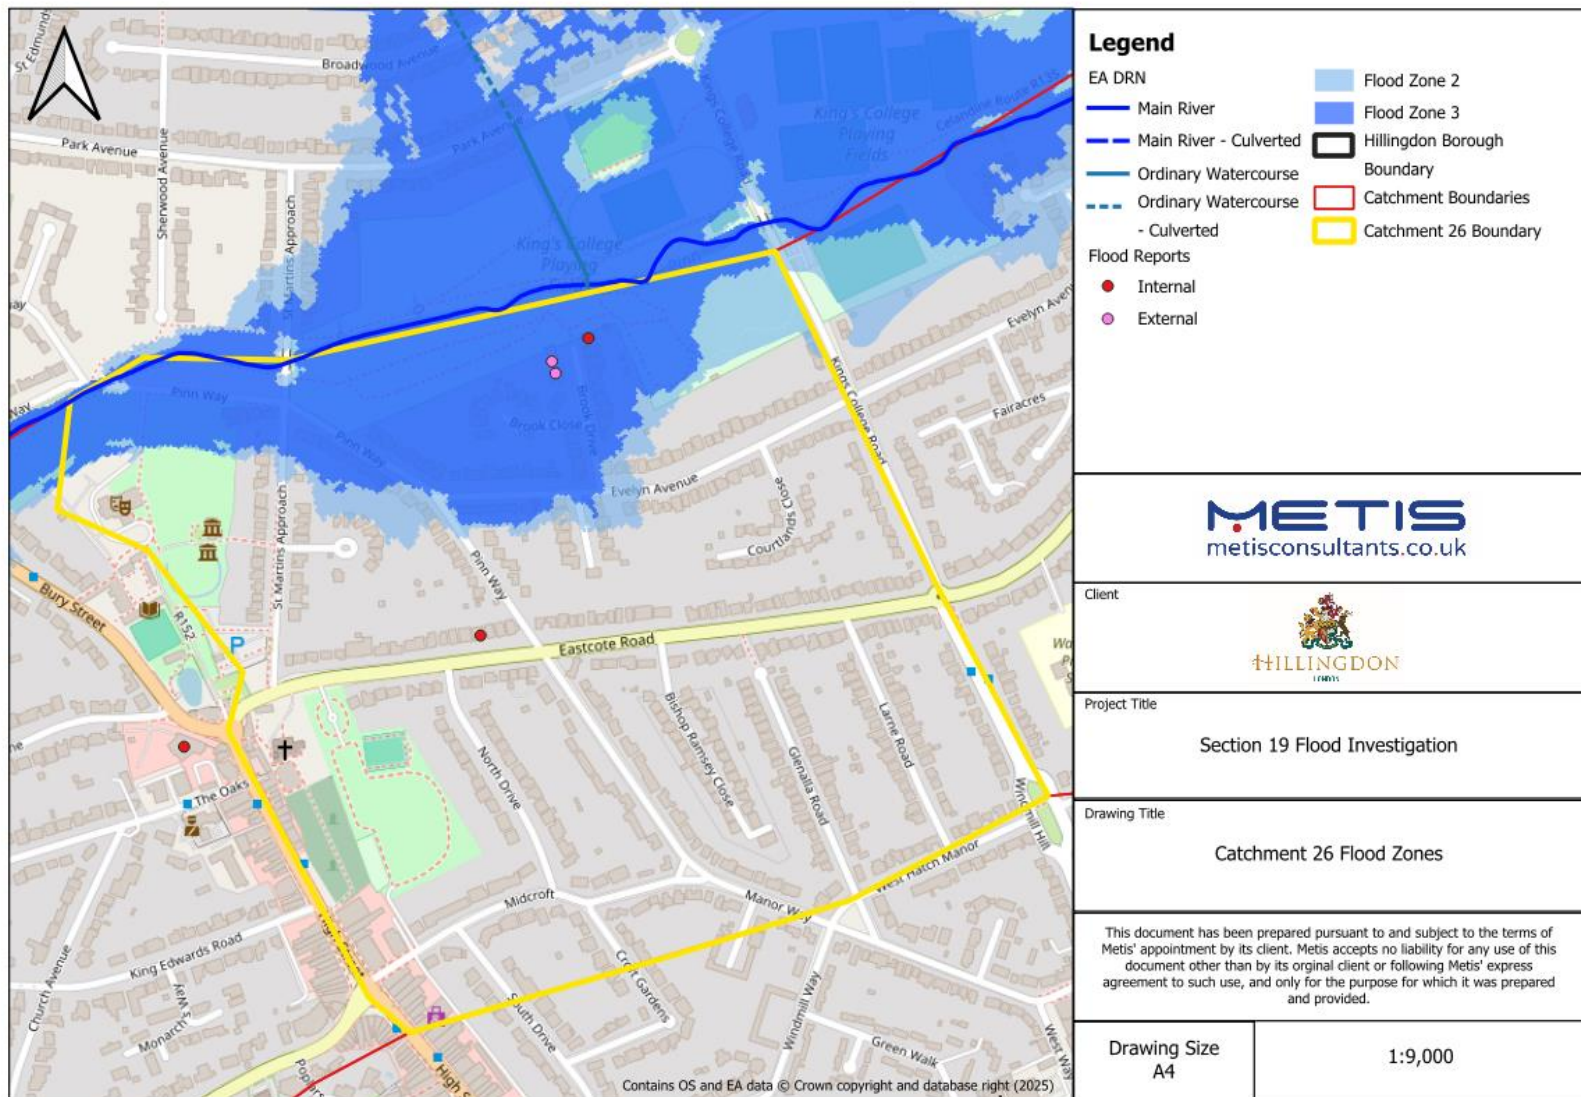
- 11.1.4 As seen in figure 11-3, the north section of the catchment is located in Flood Zone 2 or 3, including Pinn Meadows, Pinn Way, Brook Drive, Brook Close and Evelyn Avenue.

Figure 11-3: Catchment 26 flood incidents and Flood Zones.

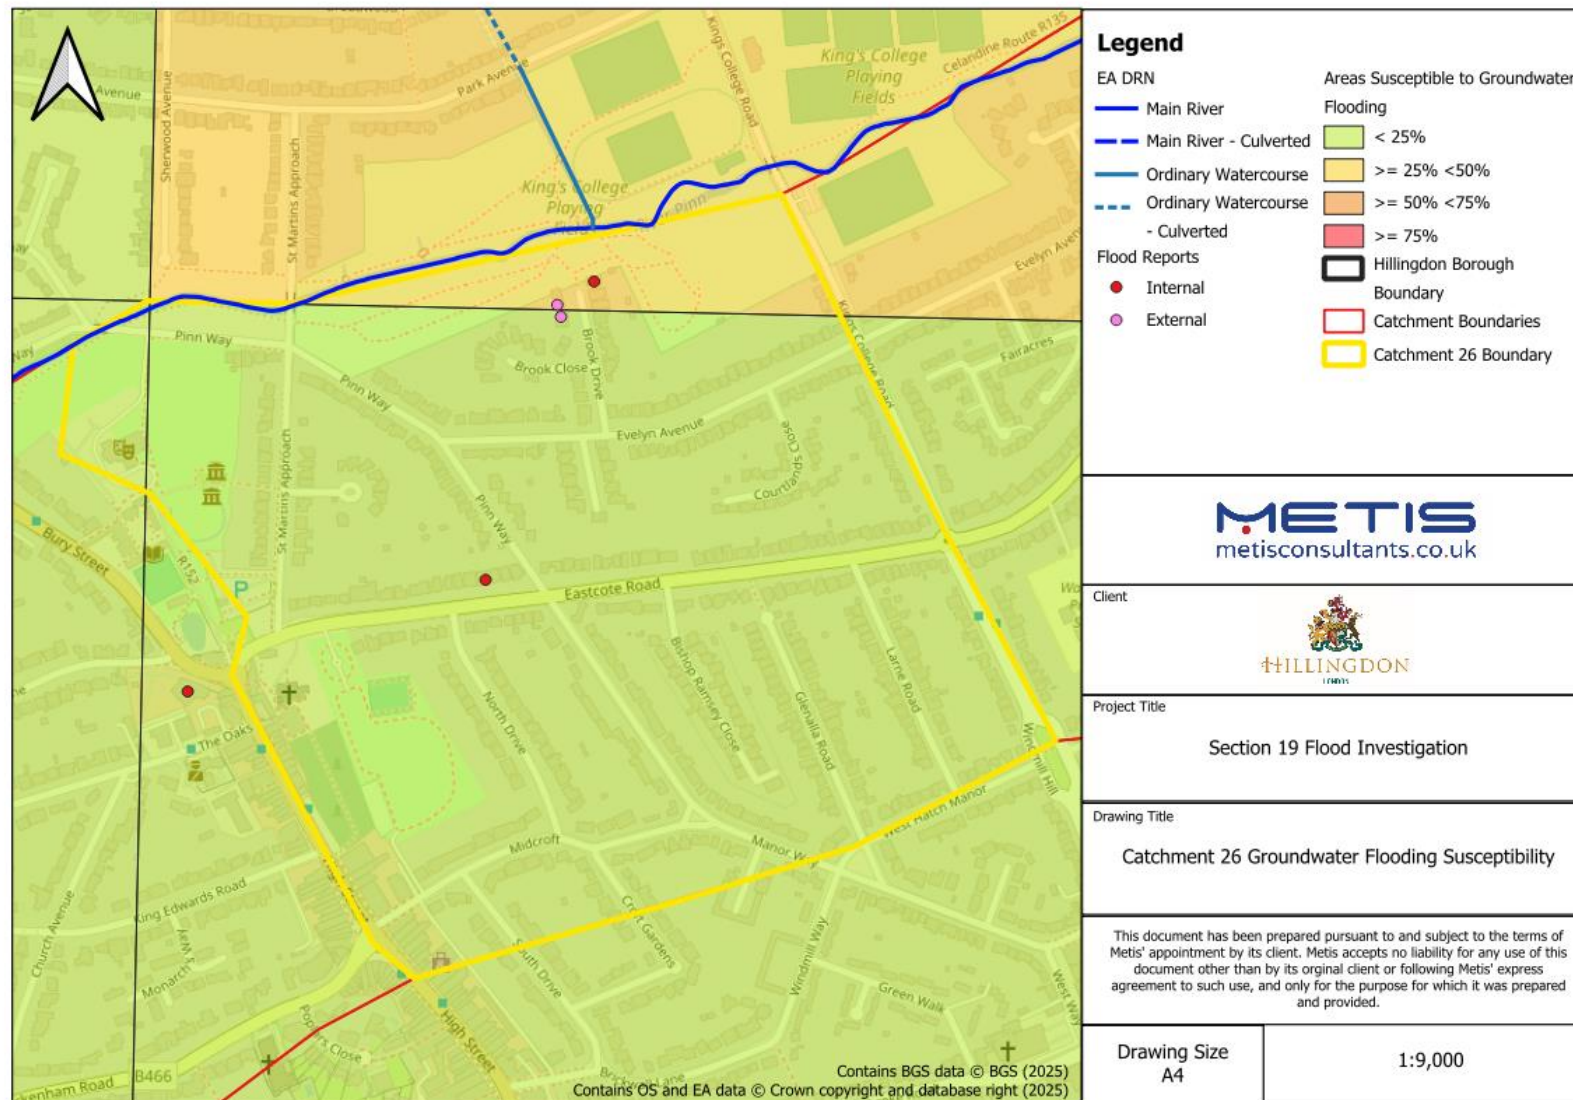
- 11.1.6 Figure 11-4 shows that the majority of the catchment is at less than 25% susceptibility to groundwater flooding. A small area in the north which includes Pinn Meadows, and some Brook Drive properties is classified as between 25% and 50% susceptible to groundwater flooding. Whilst, the groundwater may not result directly in flooding, it contributes to the excess amount of water in the catchment that struggles to be accommodated in either the river, drainage network, or open spaces.

Figure 11-4: Catchment 26 flood incidents and groundwater flooding susceptibility.

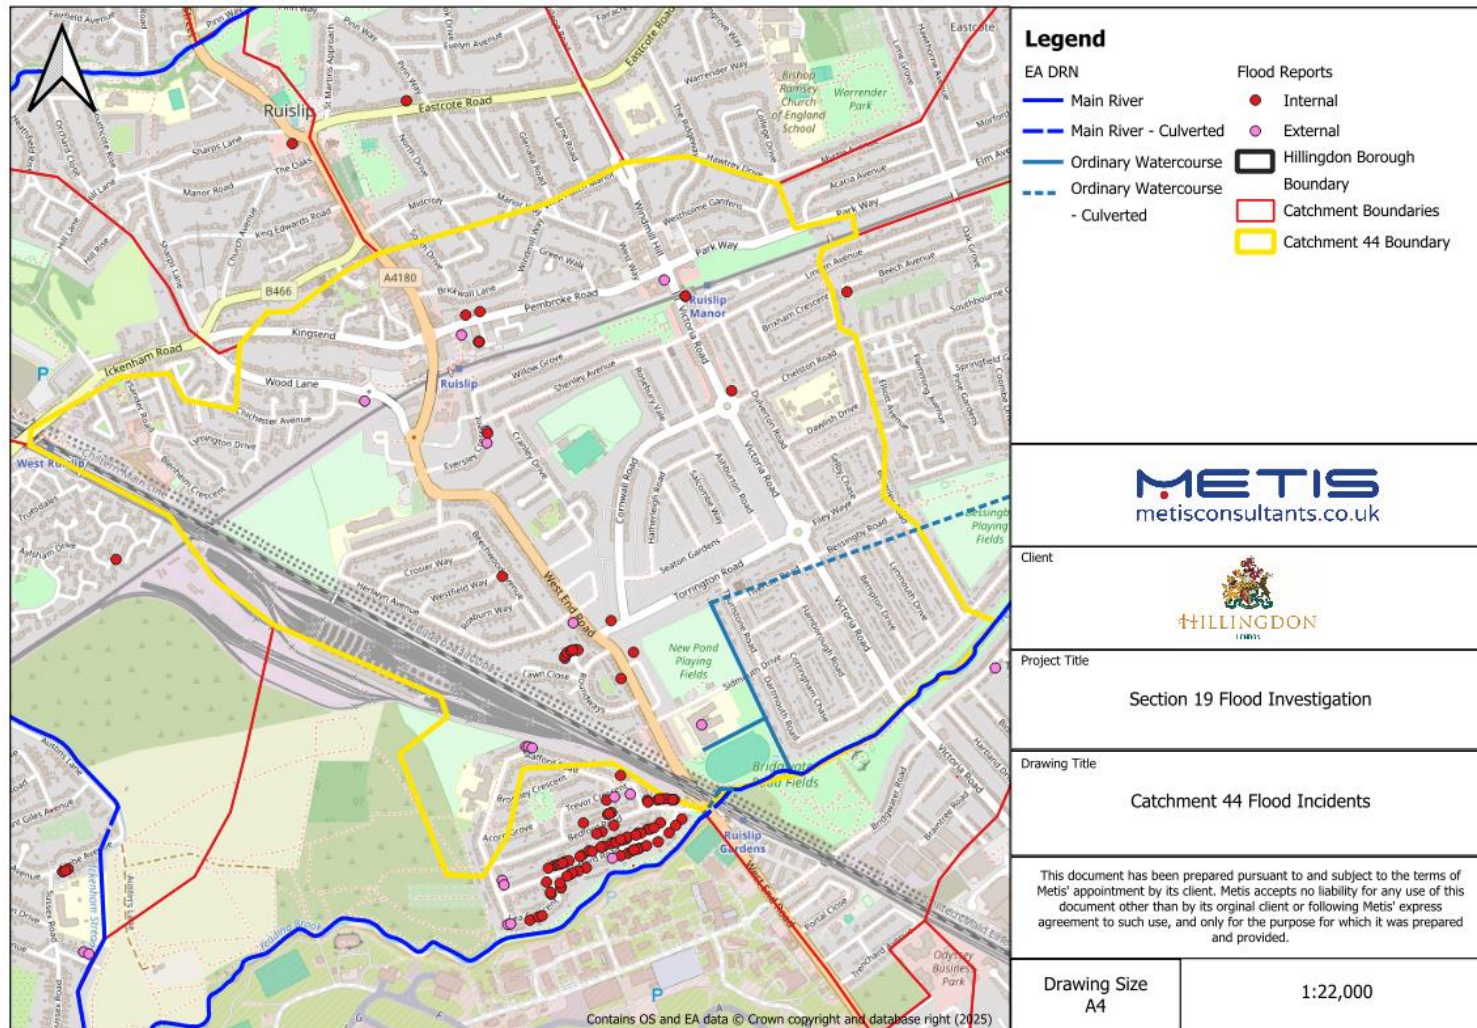
Figure 12:
Catchment 44
flood
incidents from
the 23
September
2024 flood
event.

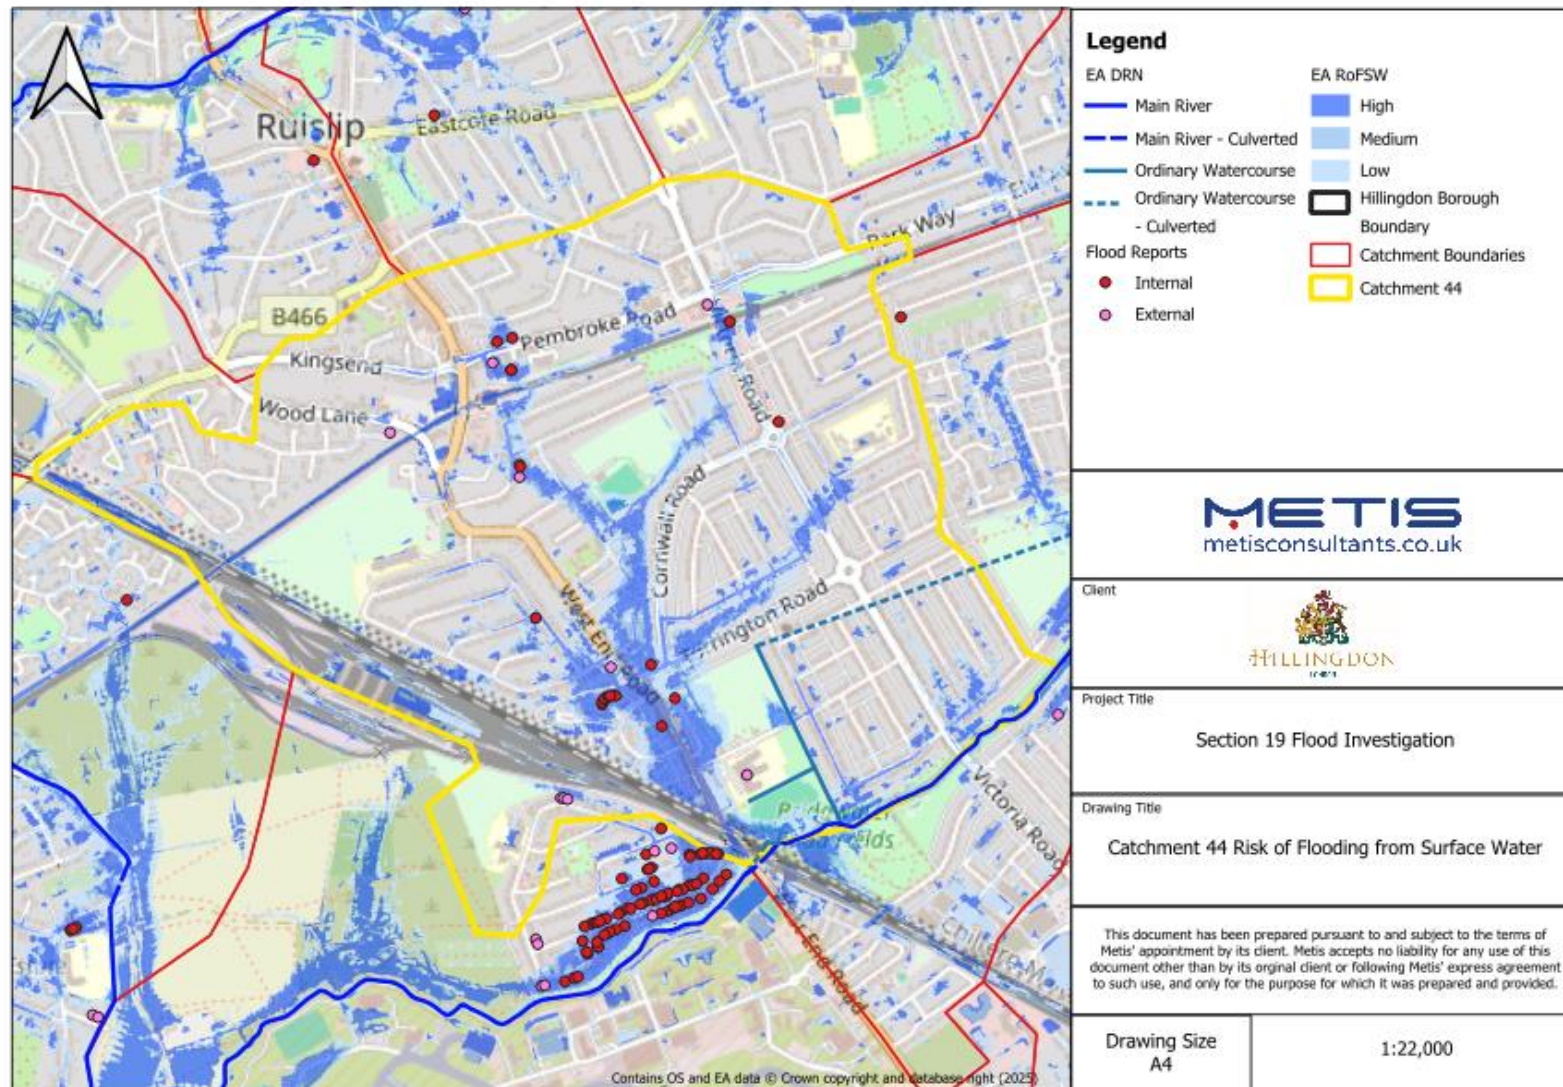
- 12.1.3 As shown in figure 12-1, there is a major surface water flow path that runs in a south-easterly direction from Pembroke Road through Eversley Crescent. This converges south of Grosvenor Vale with another major surface water flow path that runs in a south-westerly direction from Park Way through Victoria Road. The combined flow path continues south, joining with flow paths from Beechwood Avenue and Seaton Gardens and leading to a large area of high predicted risk of surface water flooding in the south of the catchment. This area includes Cherry Close, West End Road, and Berkeley Close.

Figure 12-1: Catchment 44 flood incidents and Risk of surface water flooding.

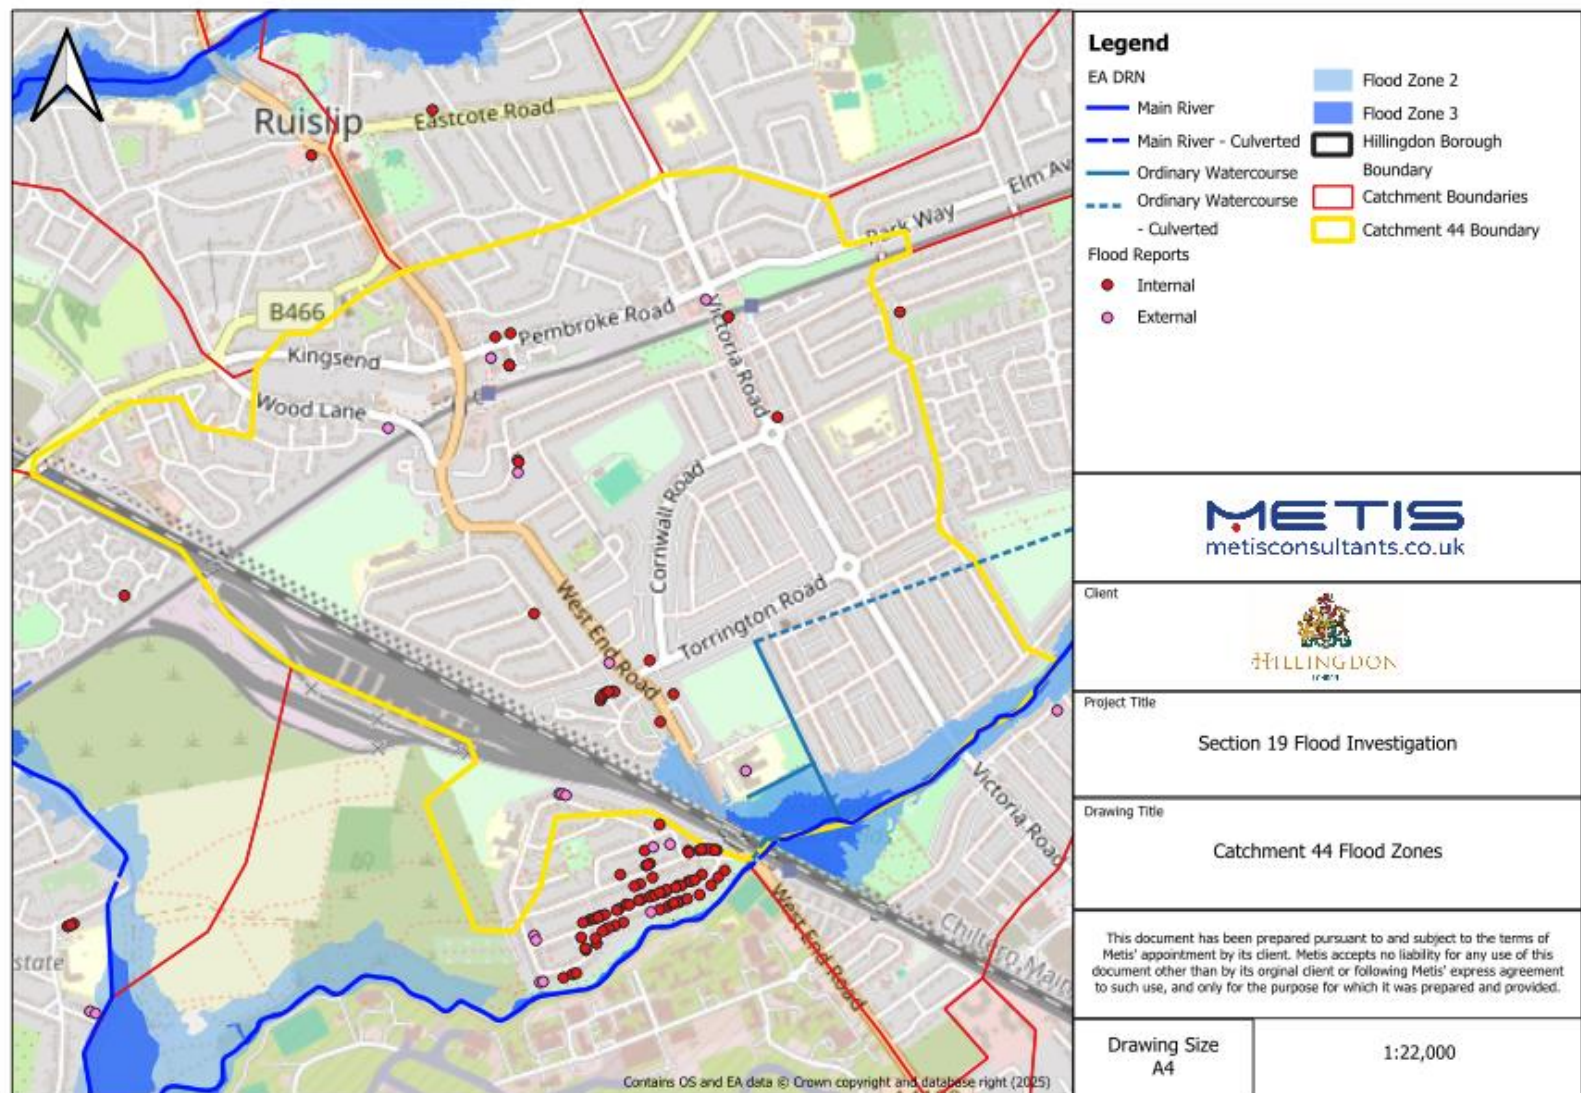
- 12.1.4 As seen in figure 12-2, some Dartmouth Road, West End Road, Bell Close, and Roundways properties are located in Flood Zone 2. Bridgewater Road Fields in the south of the catchment is located in Flood Zone 3.

- 12.1.5 Figure 12-2 also shows that there is an ordinary watercourse that runs culverted in a south-westerly direction from the east of the catchment. This ordinary watercourse becomes an open channel in New Pond Playing Fields and runs south to join the Yeading Brook West. A tributary to this ordinary watercourse runs along the southern boundary of Ruislip High School. Therefore, there may be risk of flooding from ordinary watercourses near New Pond Playing Fields or Ruislip High School.

Figure 12-2: Catchment 44 flood incidents and Flood Zones.
