Section 19 Flood Investigation

23 September 2024 Flood Event

HILLINGDON
LONDON

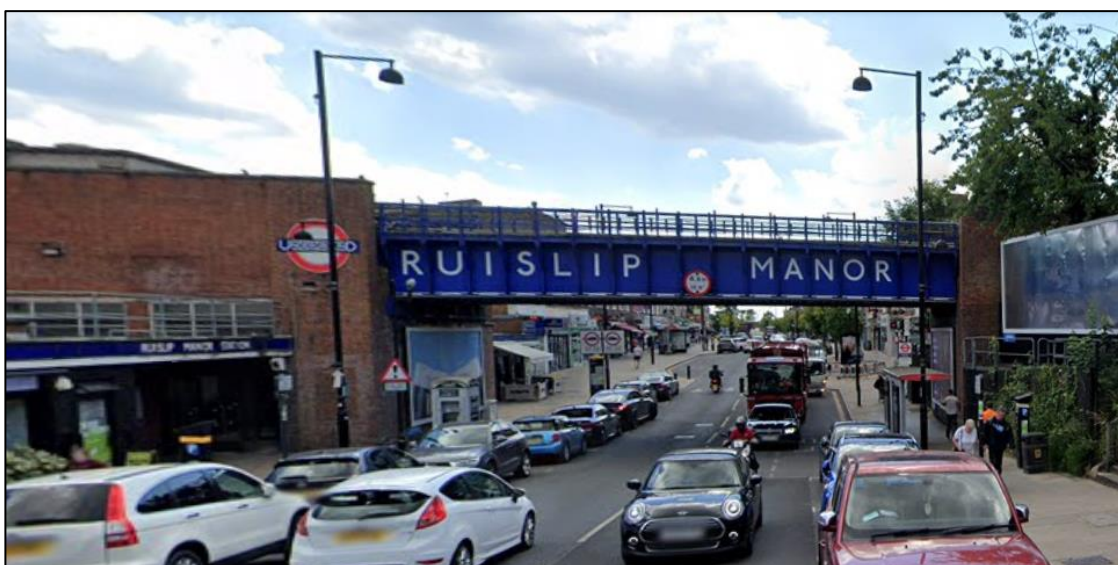
- 12.2.2 On the 23 September 2024, the surface water pooling here was extensive enough to reach the entrance of the station. For Pembroke Road, Victoria Road, and Beechwood Avenue, the flood-affected properties are located at a lower elevation than the highway. Thus, surface water was able to accumulate and enter the front of these properties through low-lying air bricks and doors. Meanwhile, the flood-affected properties along West End Road and Berkeley Close are located at lower elevations compared to the adjacent areas of open green space that they back onto, therefore surface water accumulated and entered at the back of these properties through low-lying air bricks and doors.

Figure 12-4: Entrance to Ruislip Manor Station along Victoria Road. Image credit: Google Earth.

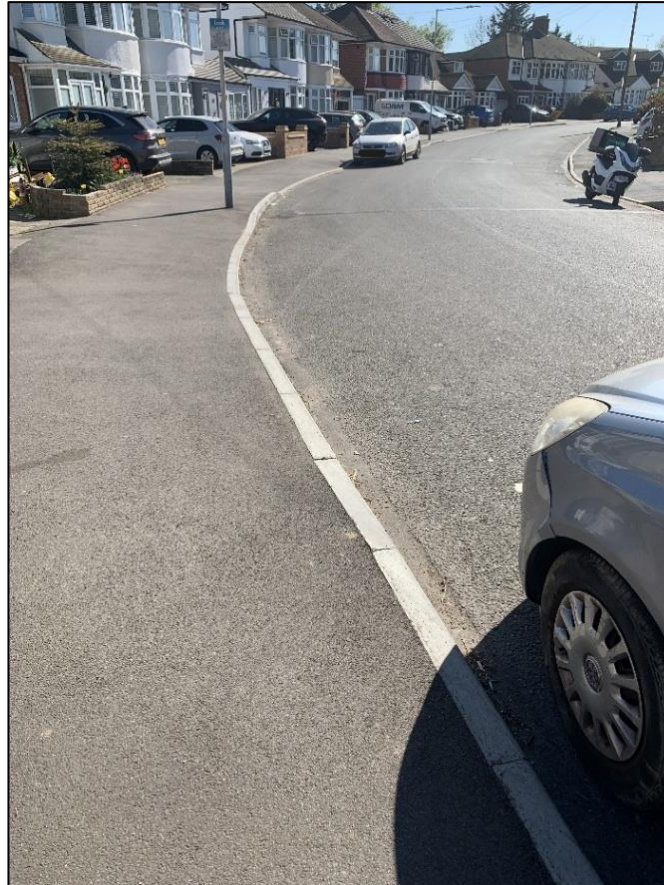
- 12.2.3 The flood-affected property along Eversley Crescent is not located at local low point in the topography. However, it is located at bend in the highway, as shown in *Figure 12-5*. With no gully in a position to intercept the runoff, surface water from further north in the catchment likely travelled straight down Eversley Crescent, overtopped the dropped kerb at the bend, flowed into the driveway, and entered the property through the low-lying air bricks and door.

Figure 12-5: Photograph of Eversley Crescent. Image credit: Metis Consultants Ltd.

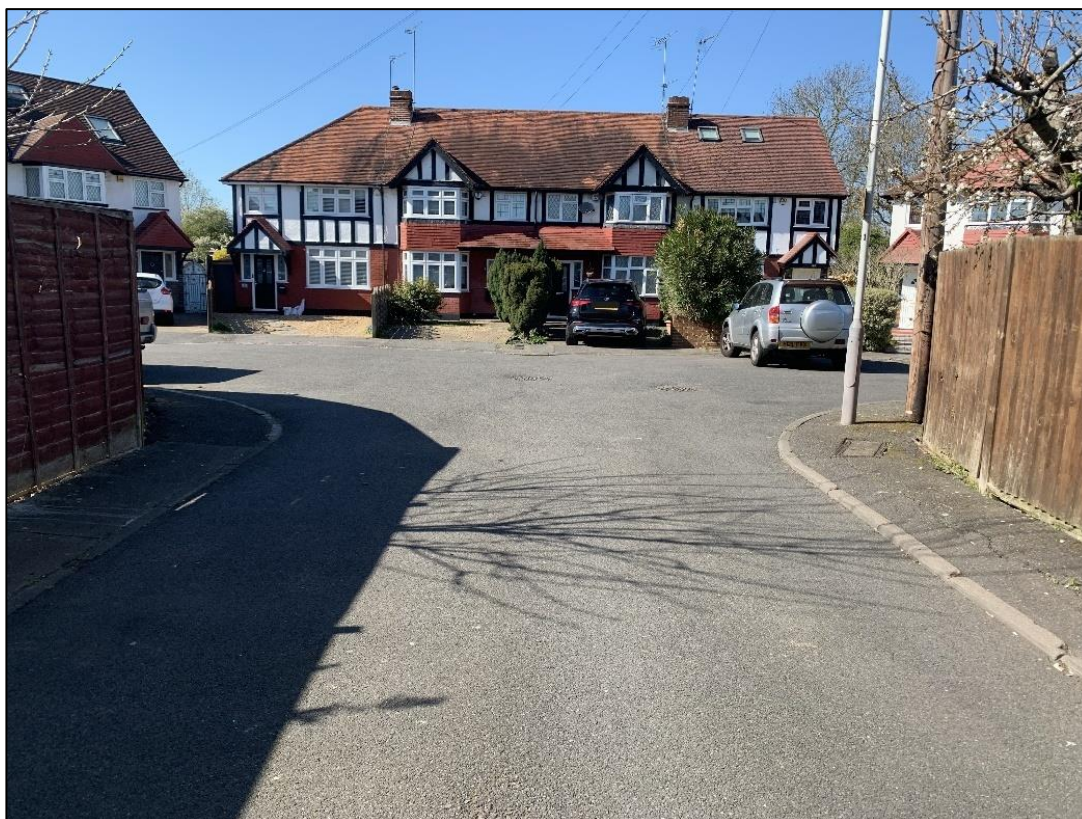
- 12.2.5 Finally, there is a sloped entrance to Cherry Close, as shown in *Figure 12-6*, which allowed surface water from Roundways to flow towards the Cherry Close properties. There is only one gully that serves Cherry Close. During the site visit, standing water could be seen within this gully, despite there being no rainfall at that location on the 7 April 2025. This indicates a capacity issue or possible blockage within the drainage network here. It is likely that the gully was ineffective at draining surface water away, and thus the surface water had nowhere to go except towards the Cherry Close properties, causing internal flooding to the entire close.

Figure 12-6: Photograph of Cherry Close. Image credit: Metis Consultants Ltd.
