LARNE ROAD AND WEST HATCH MANOR - CONDITION OF CARRIAGEWAY SURFACE

Purpose of report	This report has been produced in response to a petition signed by 17 residents of Larne Road and West Hatch Manor, requesting that road and footway surfaces be replaced and the road lining be reviewed.
Contribution to our plans and strategies	A safe Borough, a clean and attractive Borough.
Financial Cost	£54,000 – Larne Road £54,000 – West Hatch Manor
Relevant Policy Overview Committee	Residents' and Environmental Services Policy Overview Committee
Ward(s) affected	Eastcote and East Ruislip Ward

APPENDIX 'B' – PHOTOGRAPHS OF EXISTING ROAD – OCTOBER 2009

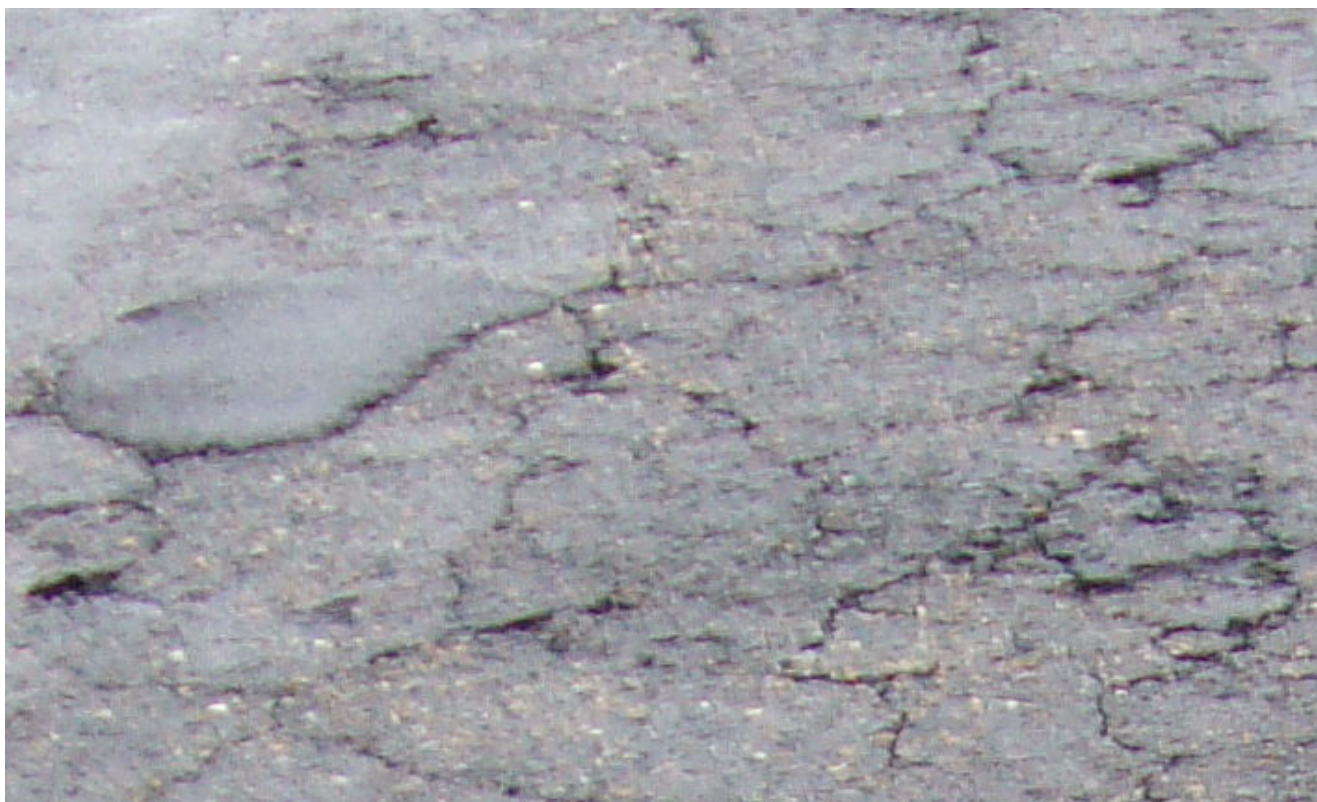
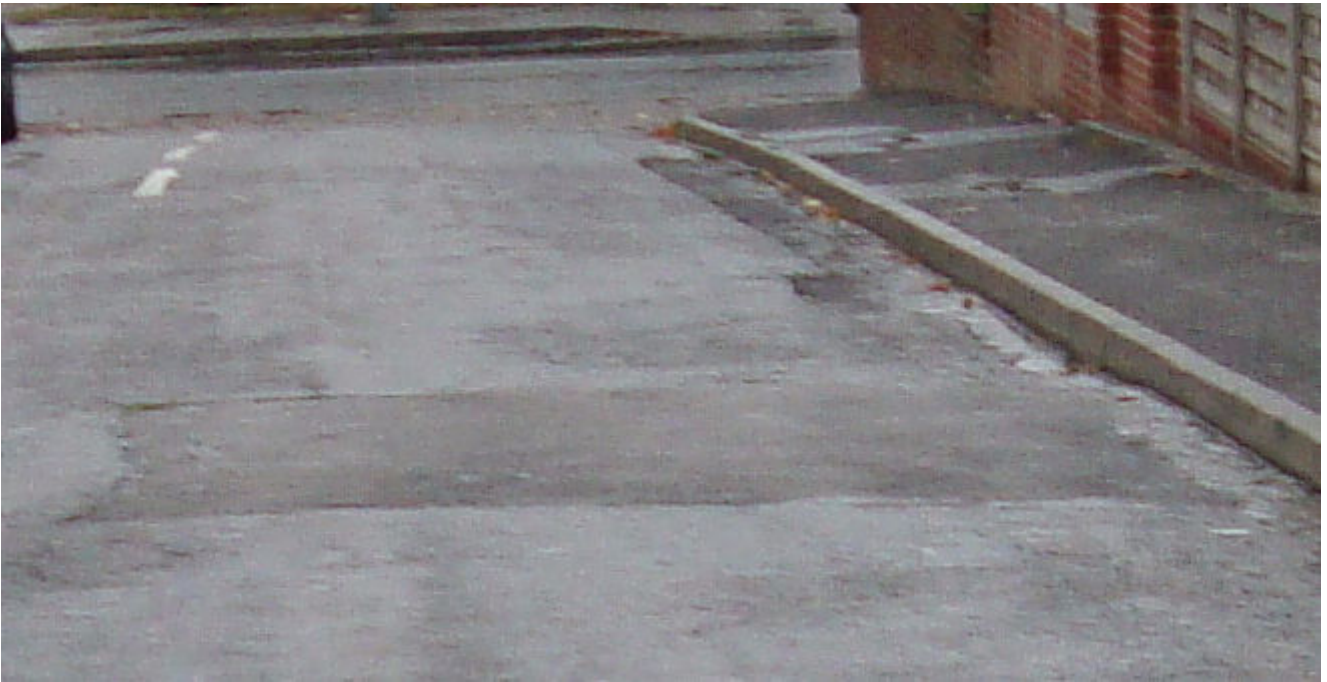
Both the existing West Hatch Manor and Larne Road carriageways have suffered significantly within a relatively short period of time and there is evidence of crazing and rutting in significant areas with shallow fretting in isolated areas. This is partly due to the natural ageing of the bituminous surface, which is now breaking up after an estimated life of at least 43 years. More significantly, the uppermost structural layers in West Hatch Manor and Larne Road appear to be failing, with trench reinstatements in Larne Road and West Hatch Road creating a patchwork effect in the carriageway, with some settlement and fretting of these reinstatements.

are losing structural integrity and are recommended for strengthening. Officers consider these roads to be high priority on both surface condition and 'Serviceability' criteria such as appearance and ride quality, etc. In addition there are areas exhibiting fretting and in some cases these are greater than 40mm, the minimum intervention level for immediate repair for dangerous defects on carriageways. Furthermore there were some potholes visible, which have now been temporarily repaired as a safety measure.

1. Placing Larne Road and West Hatch Manor on the list for structural resurfacing.
2. Placing Larne Road footway on a future resurfacing programme.
3. Continue to monitor West Hatch Manor footway and ensure any responsive maintenance works to damaged kerbs, defective bituminous areas or concrete paving slabs are implemented as necessary.
4. Carrying out a review of the thermoplastic road lines, particularly at the junctions with West Hatch Manor and implement re-lining where appropriate.
